WEST RIDGE--PETERSON AVENUE  
REDEVELOPMENT PLAN AND PROJECT

Finally, this Report summarizes the existing conditions according to the applicable criteria referred to in the Act and outlined above as Items 1 through 14. Photographs are used where appropriate to illustrate existing blighted conditions. Photographs appear as Exhibit D and are referenced throughout the text.

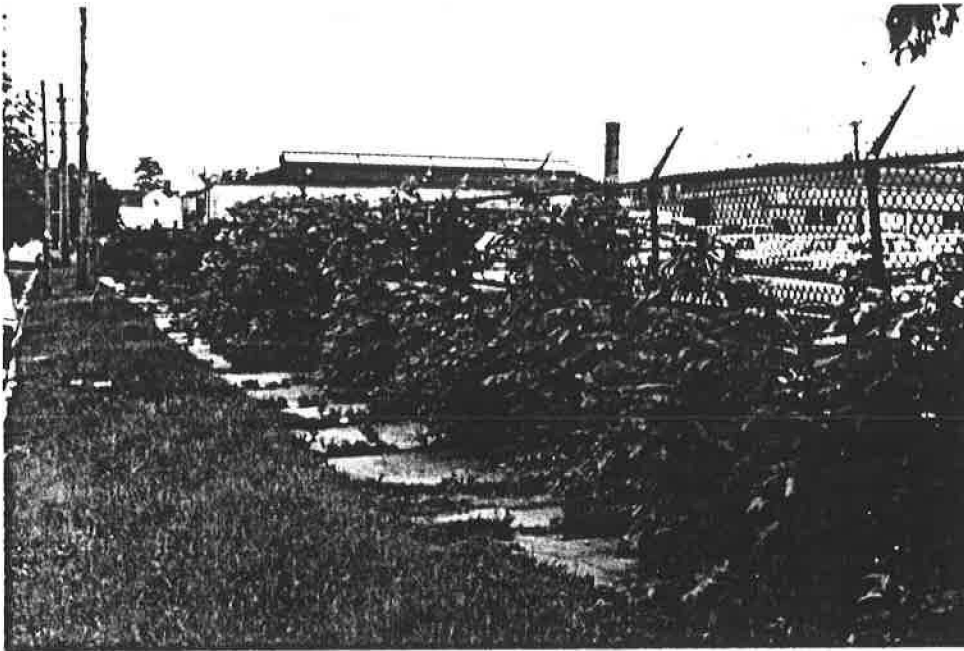
Results of Investigation: A chainlink fence borders the north property line of the site for approximately 800 feet and is situated atop a concrete retaining wall. This fence is rusting. The posts on the retaining wall are bent. Weeds are growing over the sidewalk along the retaining wall.

Evaluation: The rusty condition of the fence, bent posts, and weed overgrowth are the result of depreciation of physical maintenance and deterioration.

PHOTO A-1  
Weed overgrowth  
along north  
retaining wall.

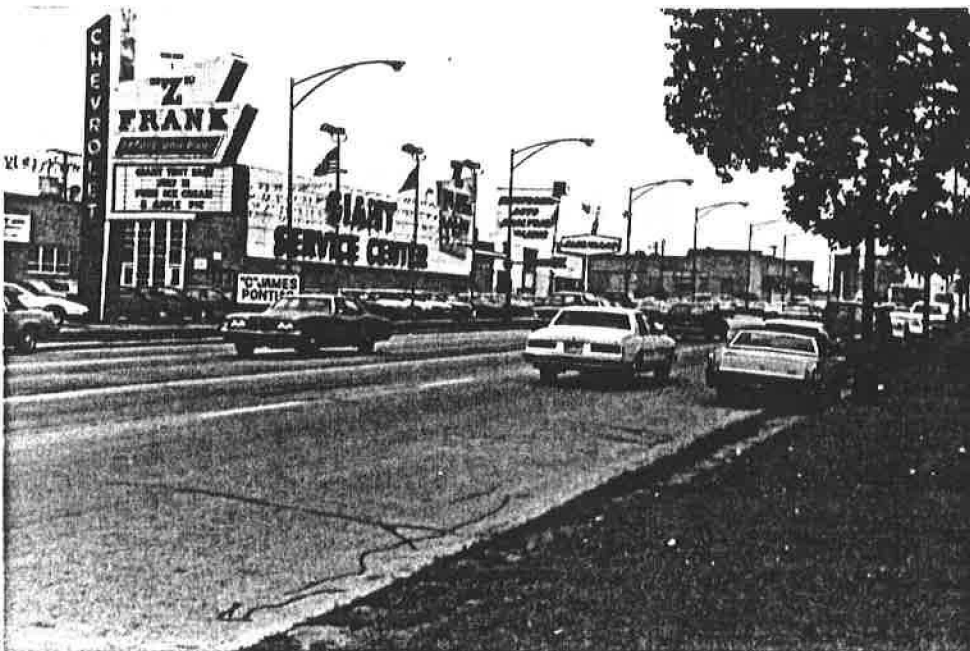
Results of  
Investigation: Signage on the facility includes free-standing illuminated, building-mounted neon, and non-permanent signs. For a facility which contains only two principal uses, the site signage is excessively cluttered, of a style no longer current, and its physical condition is deteriorating (See Photo A-3 and Photo A-4).

Evaluation: The deterioration of the signs represents age and depreciation of physical maintenance, while the basic character of the signs and the manner in which they are used are obsolete.

PHOTO A-3  
Site signage.

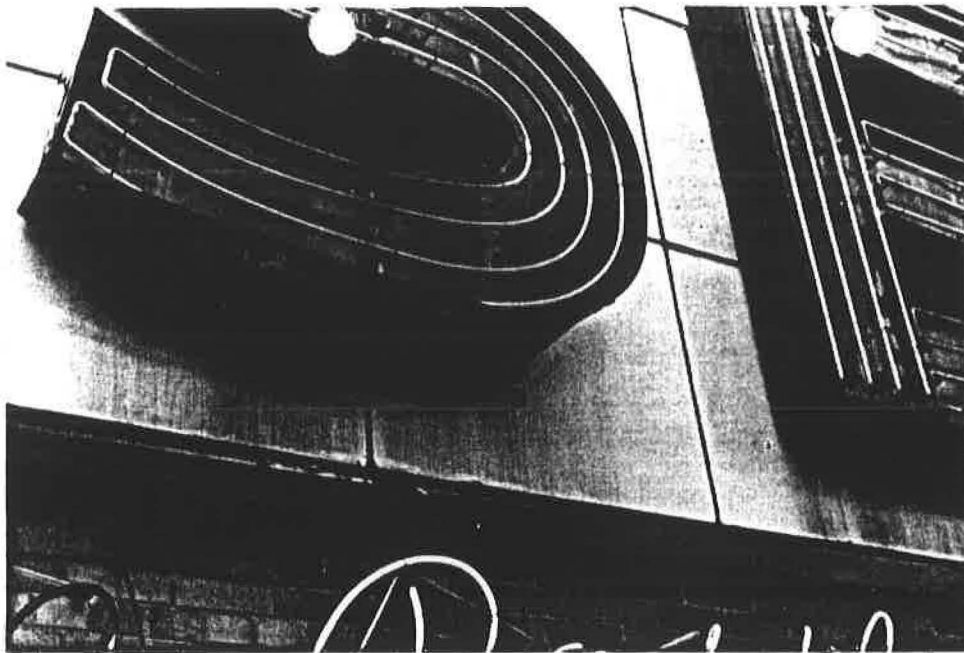
PHOTO A-4  
Deteriorating  
condition of  
building signage.

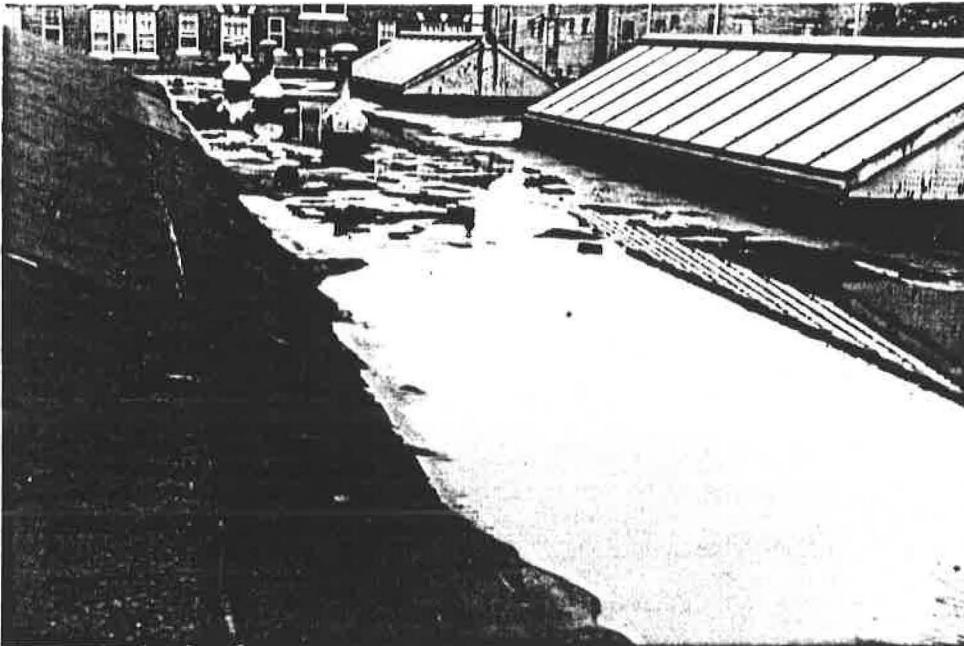
All of the existing flat roof areas are built-up asphalt that are severely blistered and splitting. Many areas are covered by ponding stormwater (See Photo A-5) which contributes to the deterioration of the roof membrane. The flashing has pulled away from the walls allowing large holes for water to enter the parapet walls. The wood roof deck has been replaced in some areas due to water damage and additional areas of deck are probably in poor condition due to the evidence of roof leaks. Since the majority of the facility was built in the 1950's, there is a lack of adequate insulation by today's design standards, resulting in an energy inefficient structure.

The roofing has aged beyond its useful life as evidenced by the numerous roof leaks throughout the facility. Complete replacement of the roofing system would be required to obtain proper weatherability. The roof's condition is dilapidated, deteriorated and evidence of depreciation of physical maintenance. Inadequate insulation is evidence of age and obsolescence.

PHOTO A-5  
Ponding water on  
roof and skylights.

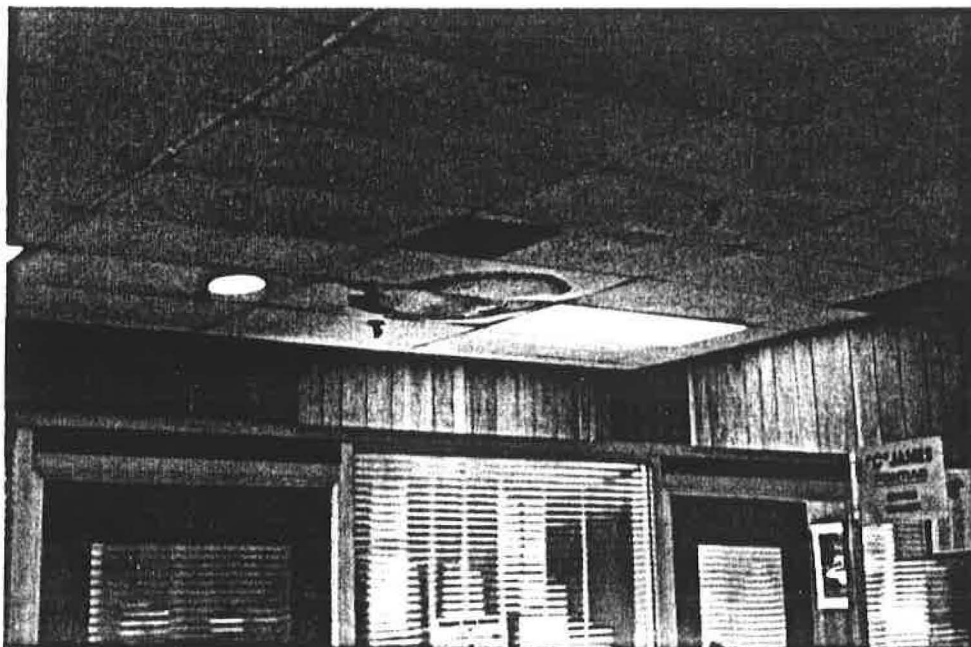
Non-bearing interior walls are masonry and wood stud. Efflorescence, the by-product of salts leeching from the brick and mortar, has occurred on the inside of the masonry walls due to water penetration from leaking roofs and deteriorated flashing, causing brick to crack and spall. The majority of material finishes are extremely dated wood paneling which is of a type no longer contemporary in style. Lay-in ceilings in office area are aged and warped, and damaged due to roof leaks (See Photo A-6).

Stained ceiling tiles are further evidence of chronic roof leaks and indicate a dilapidated condition.

PHOTO A-6  
Damaged ceiling  
tiles.

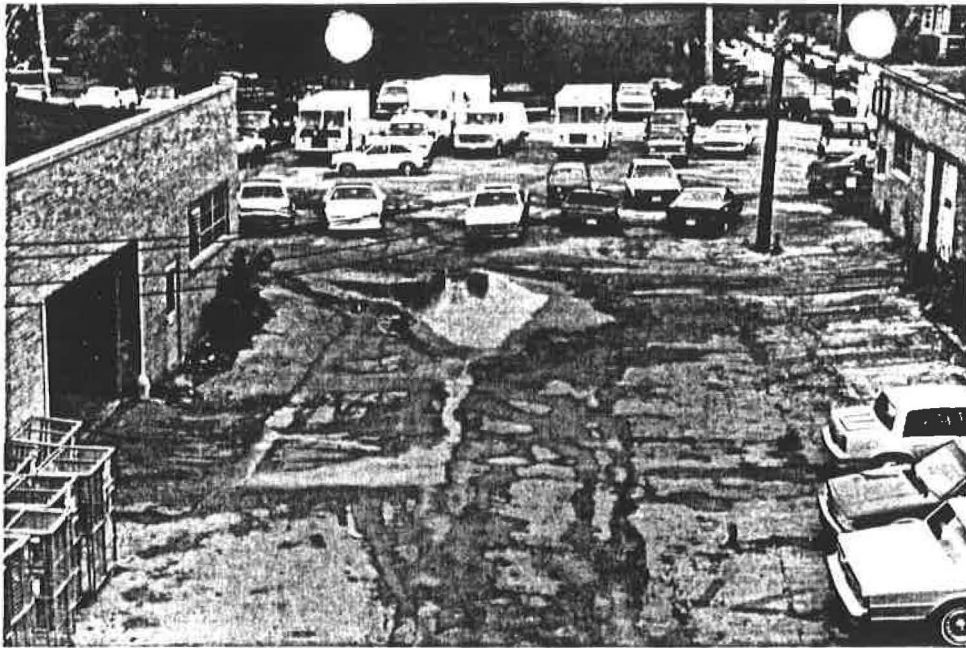
Ponding water is in violation of Sec. 78-58 of the Municipal Code of Chicago under minimum requirements for existing buildings and thus indicates the presence of a property below minimum code standards.

PHOTO C-1  
Ponding storm water.

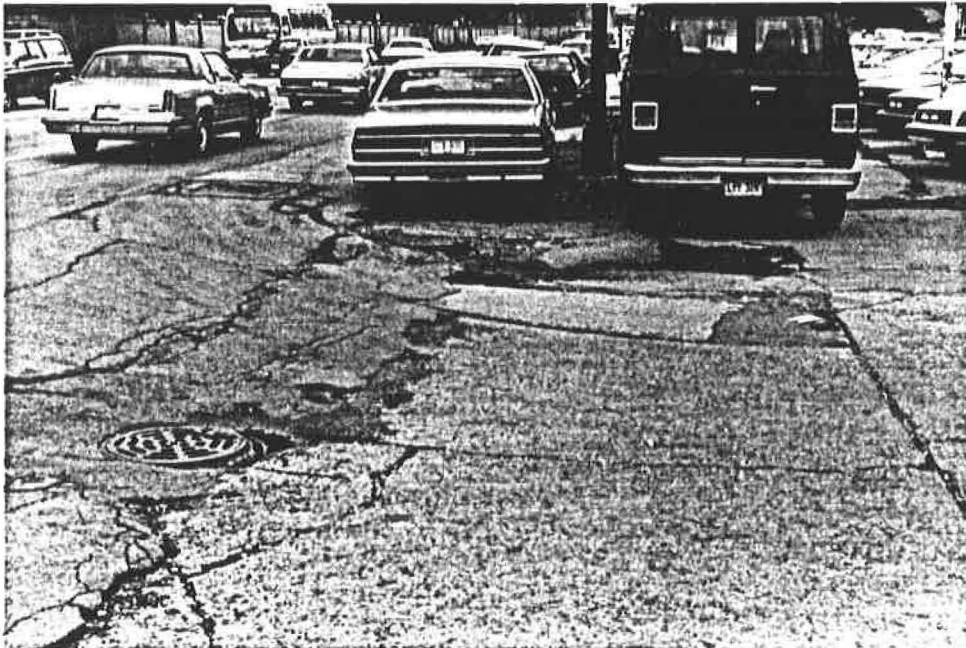
All of the site not covered with buildings is paved; the majority of this paving is asphalt. Some sections of the paving are plagued by heavy cracking and potholes and are in need of patching. Cracks in other sections need filling and most areas require sealing (See Photo C-2).

The asphalt parking lot is usable but the cracks and potholes are evidence of age, deterioration and depreciation of physical maintenance.

PHOTO C-2  
Aged and  
deteriorated paving.

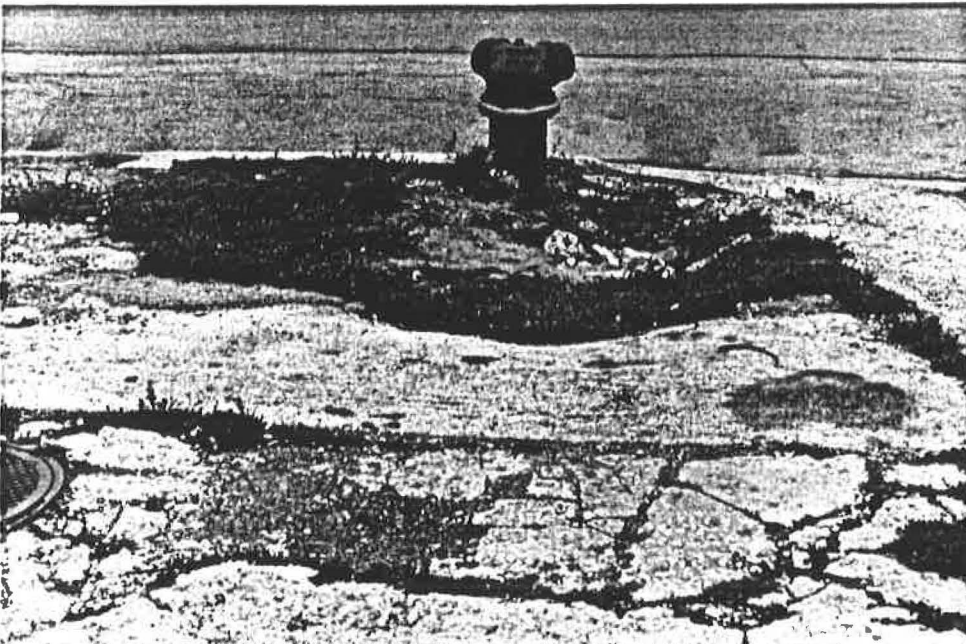
Concrete sidewalks border the south and north sides of the site. The majority of the sidewalks are heavily cracked and spalled and in need of replacement (See Photo C-3). The shortage of parking in the front of the facility, causes cars and trucks to be parked on sidewalk (See Photo C-4 and Photo C-5).

Evaluation: The cracked and spalled sidewalks are evidence of age and deterioration. Usage of the sidewalk for car and truck parking is a deleterious land use.

PHOTO C-3  
Deteriorated  
sidewalk.

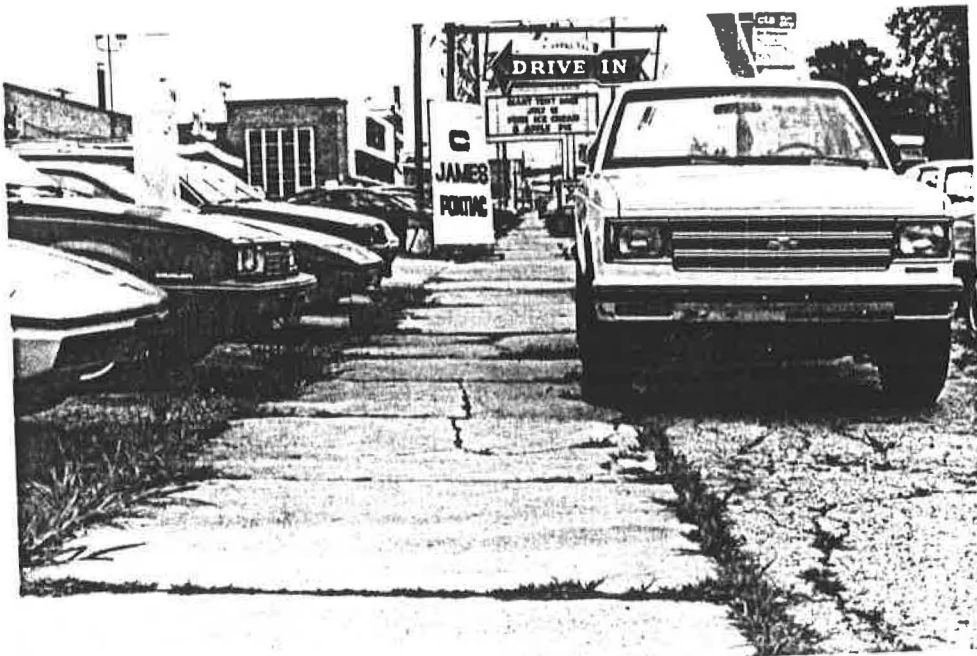
PHOTO C-4  
Parking on sidewalk.

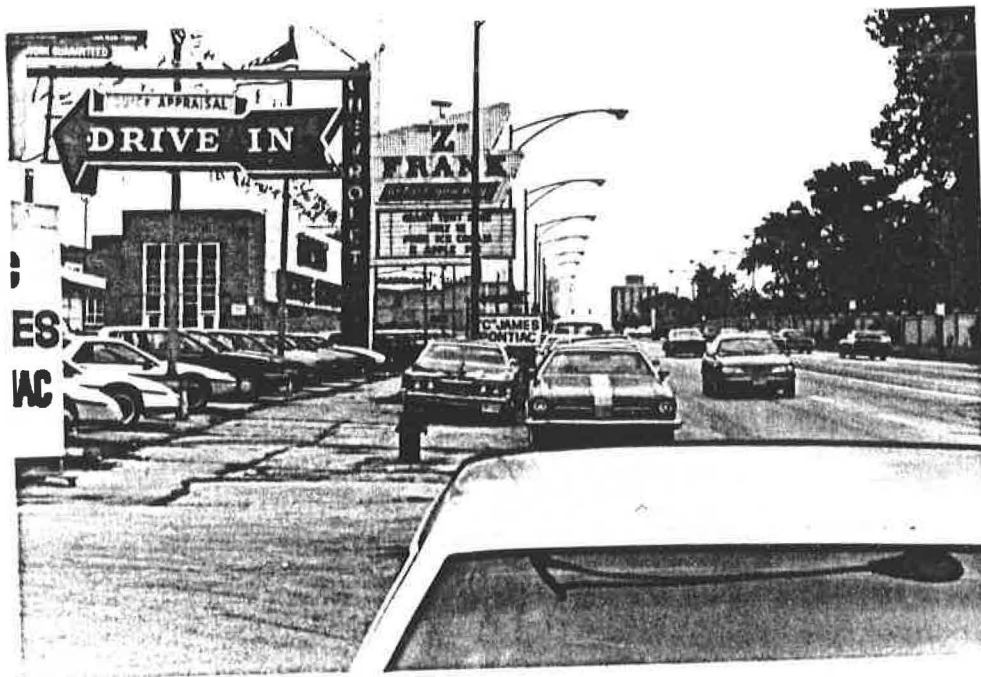
PHOTO C-5  
Parking in Parkway.

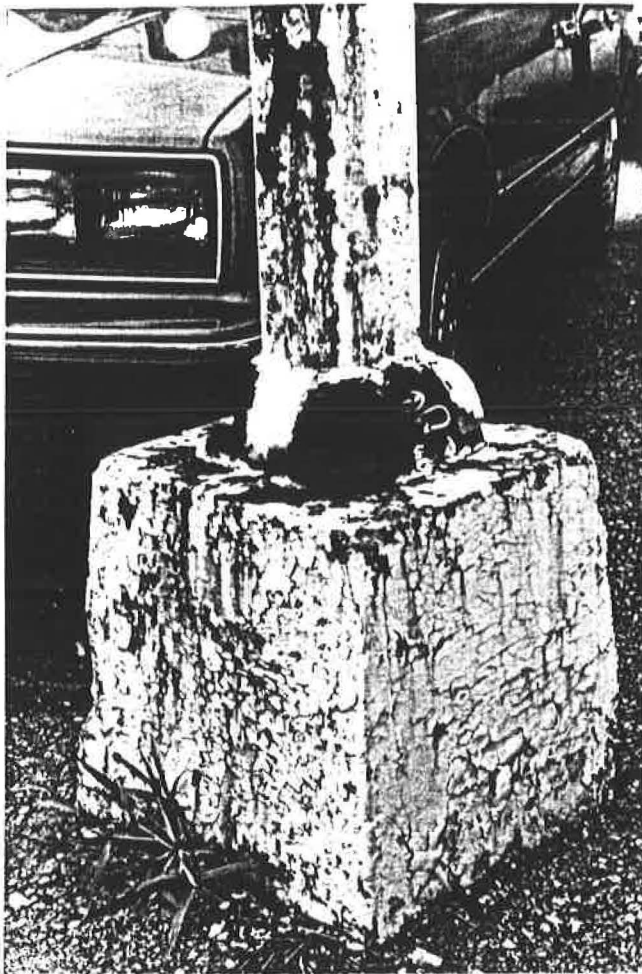
Results of Investigation: Exterior site lighting consists of pole-mounted fixtures and some building-mounted lighting at the rear of the site. Light poles are severely rusted showing signs of heavy corrosion, and are buckling or in a state of failure due to this condition. (See Photo C-6). Some are dented. All are consistently deteriorated. Concrete bases are spalled and cracked. Lighting fixtures are completely corroded, broken out and wiring is exposed. Lighting fixtures require replacement. One fixture is unattached and hanging by electrical wires.

Evaluation: The condition of the exterior light poles and fixtures is evidence of age, dilapidation, deterioration, and a general depreciation of physical maintenance.

PHOTO C-6  
Deteriorated  
lightpost.

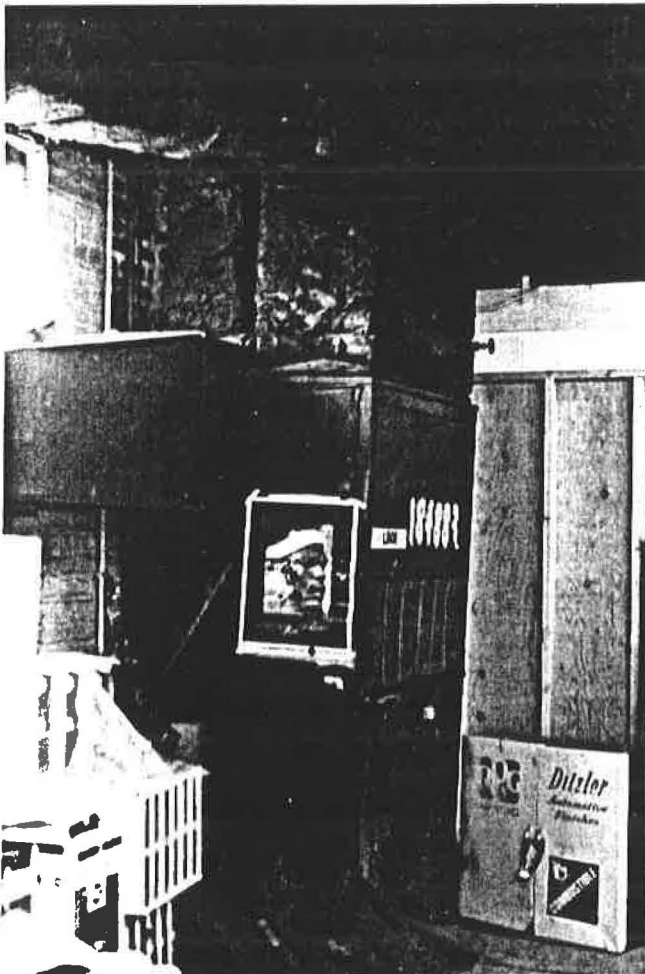
The absence of make-up air and exhaust in the toilet and locker rooms is contrary to good engineering practice and results in a lack of ventilation. The poor condition of the parts department air conditioning unit and various locker and toilet perimeter heaters indicates dilapidation and depreciation of physical maintenance.

PHOTO M-1  
Parts Dept. air  
conditioning unit.

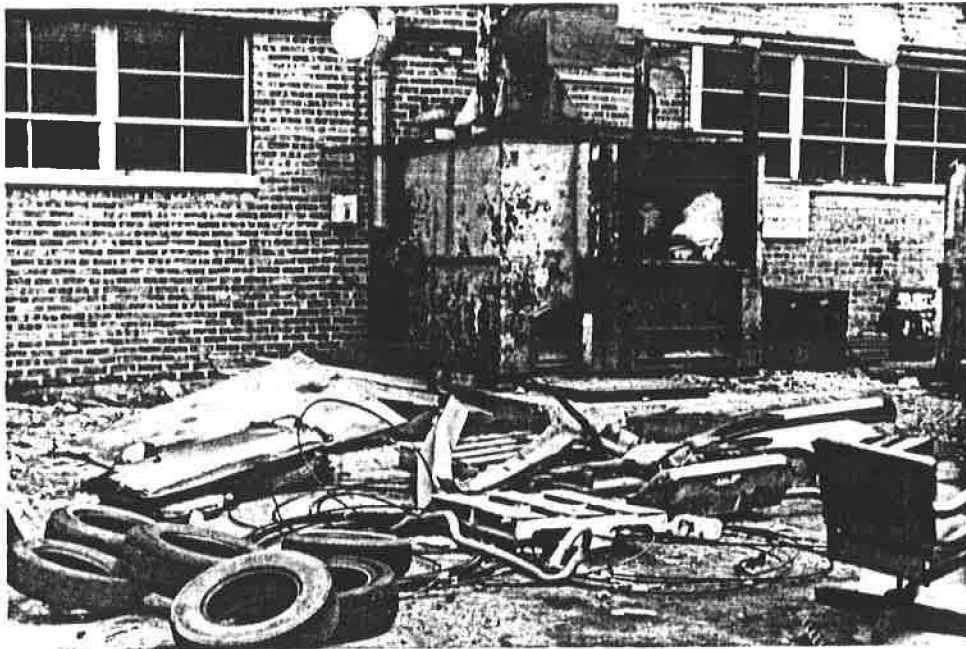
Results of  
Investigation: An abandoned incinerator is present between the Service Building and West Building near the Paint Shop and Parts storage areas. This incinerator is rusting and extremely dilapidated. (See Photo M-2)

Evaluation: The rusted and abandoned condition of the incinerator indicates age, dilapidation and a depreciation of physical maintenance.

PHOTO M-2  
Abandoned  
incinerator.

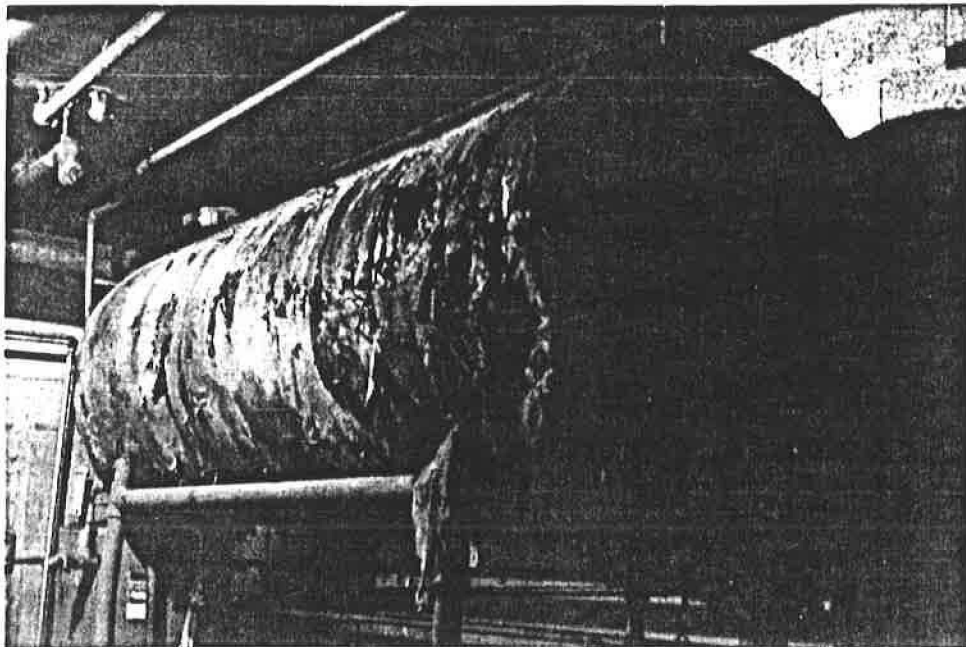
Results of  
Investigation: Most steam and condensate return lines are not insulated. Insulation on the hot water storage tank is deteriorating (See Photo M-3).

Evaluation: The absence of insulation installed on steam and condensate piping decreases the efficiency of the steam boilers thus indicating obsolescence by today's design standards. The condition of the insulation on the hot water tank is evidence of deterioration.

PHOTO M-3  
Hot water storage  
tank.

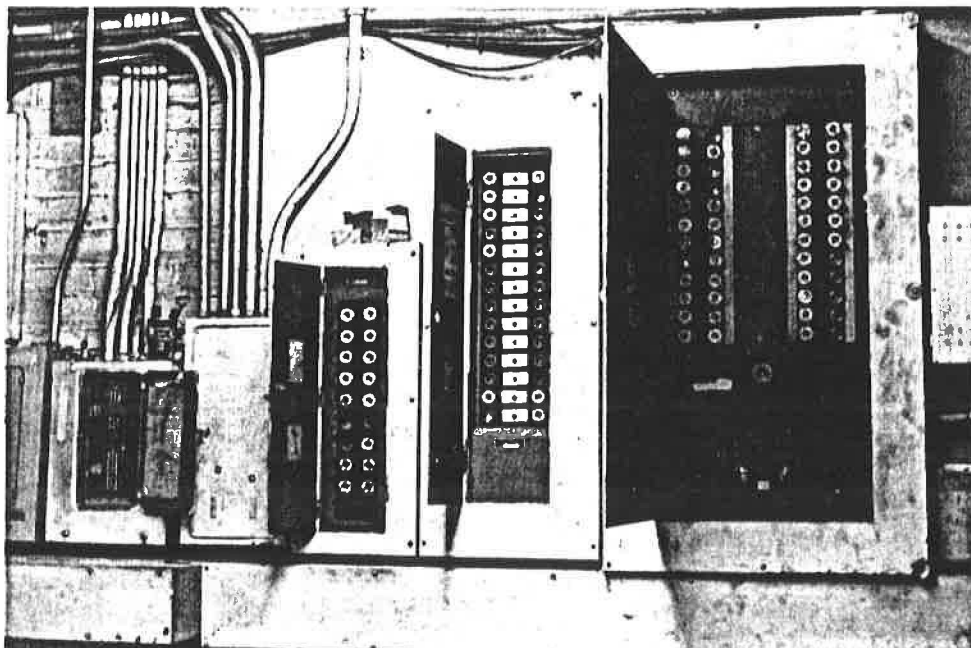
Conditions vary from building to building. In the West Building panels are plug-fuse type (See Photo E-1). These panels are rusted, corroded, missing screw fasteners, old, obsolete and not maintained. In the newer buildings, especially the Service Building and the Electraac Building, circuit breaker and fusible switch type panels are in good condition. In the showroom area all electrical devices are painted over which presents a potential safety hazard.

Modern facilities are designed and constructed with circuit breaker panels rather than fuse-type. Plug-fuse type panels in the West Building evidence the facility's age. These panels are obsolete, dilapidated, deteriorated and evidence of depreciation of physical maintenance. In the service and parts areas, the panels need replacement due to age and deterioration.

PHOTO E-1  
Obsolete  
electrical  
lighting and power  
distribution  
panels in west  
building.

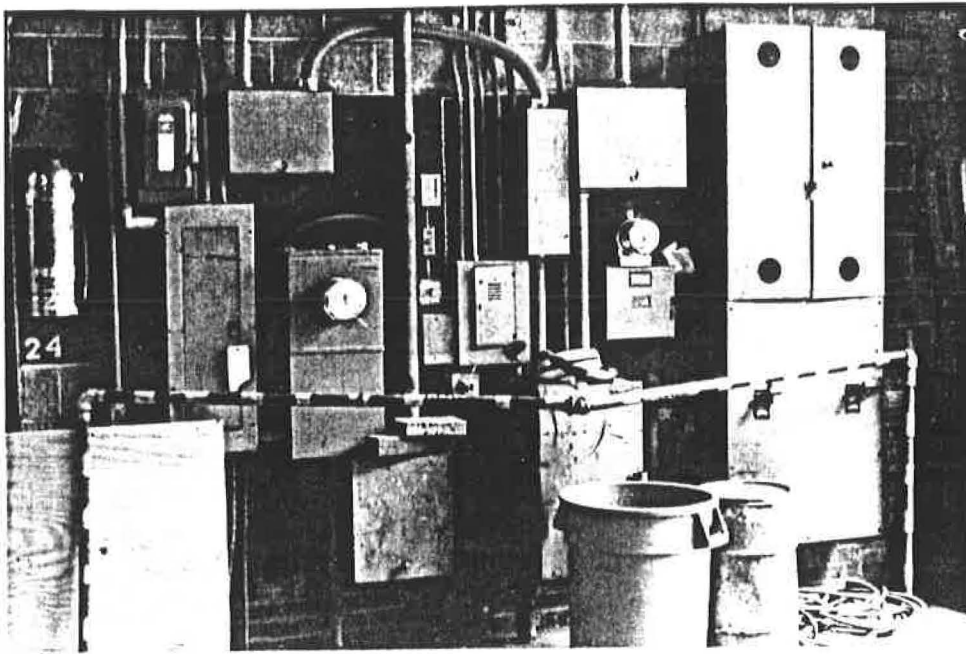
The condition of the secondary power distribution system varies with buildings. In the West Building the conduits are old and beginning to rust, pull boxes are rusted out, missing covers and screws (See Photos E-2 and E-3). Conduit and wire serving roof-top equipment are completely rusted. Pieces of conduit are missing, leaving wire exposed.

PHOTO E-2  
Rusted out  
electrical service  
distribution for  
the west building.

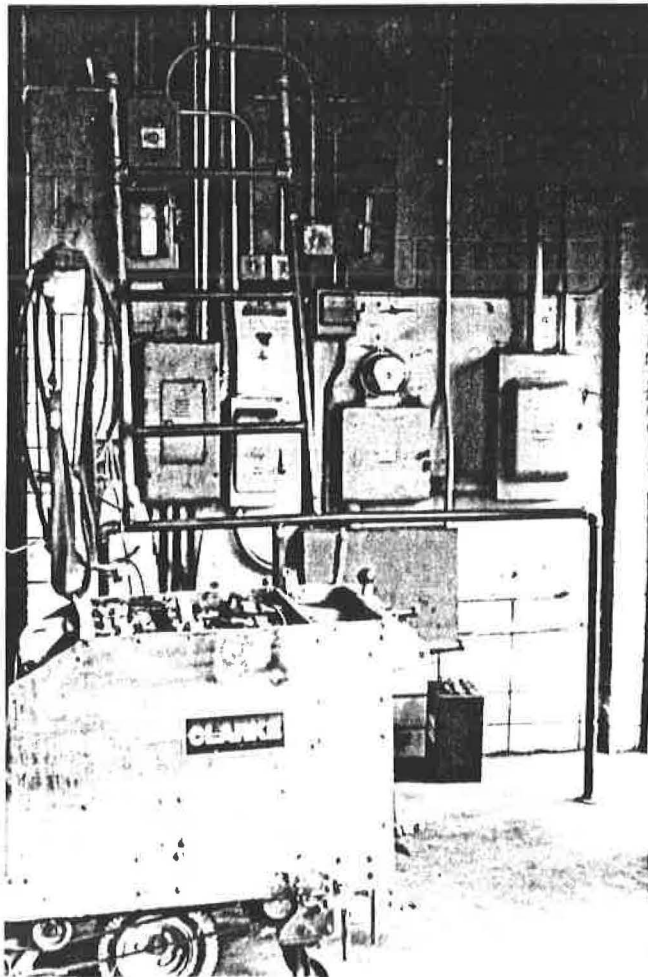
Service #2 for Service Building is from the power pole also adjacent to Service Building. The conductors are frayed, the insulation is flaking, and the service entrance equipment, which includes the metering, the main switch, and the electrical distribution panel is corroded and deteriorated.

Evaluation: The current condition of Service #2 is evidence of age, deterioration, dilapidation, and depreciation of physical maintenance.

PHOTO E-3  
Rusted out  
electrical service  
distribution  
(Service #2) in  
Service building.

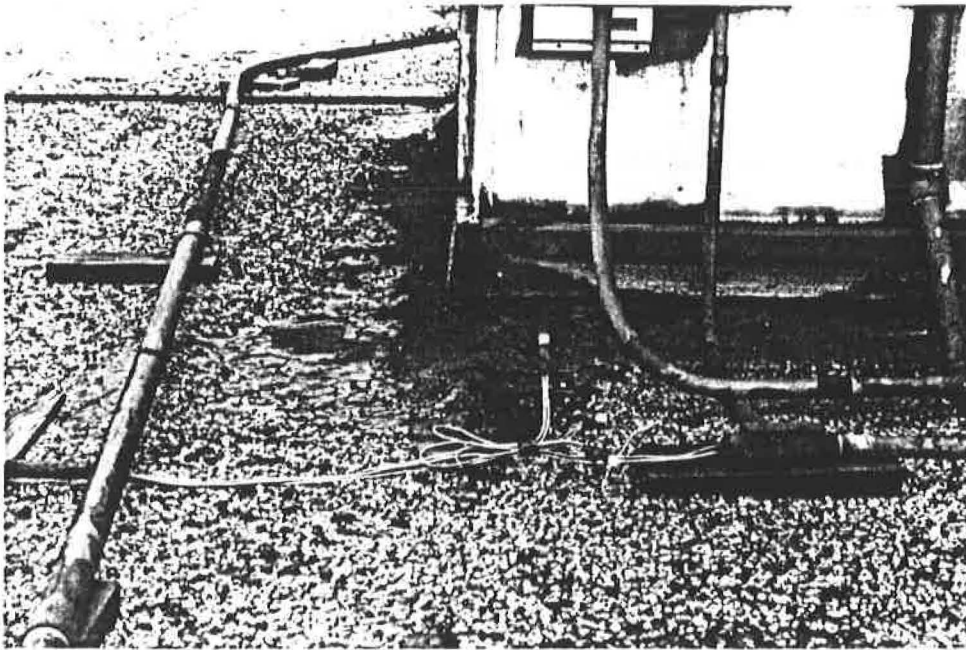
The wiring on the roof of the West Building has deteriorated beyond repair and is dangerous. This violates Section 87-300.3 of the Code and indicates the presence of structure below minimum code standard. (See Photos E-4 and E-5).

PHOTO E-4  
Eroded conduits  
and exposed wiring  
on the roof of  
west building.

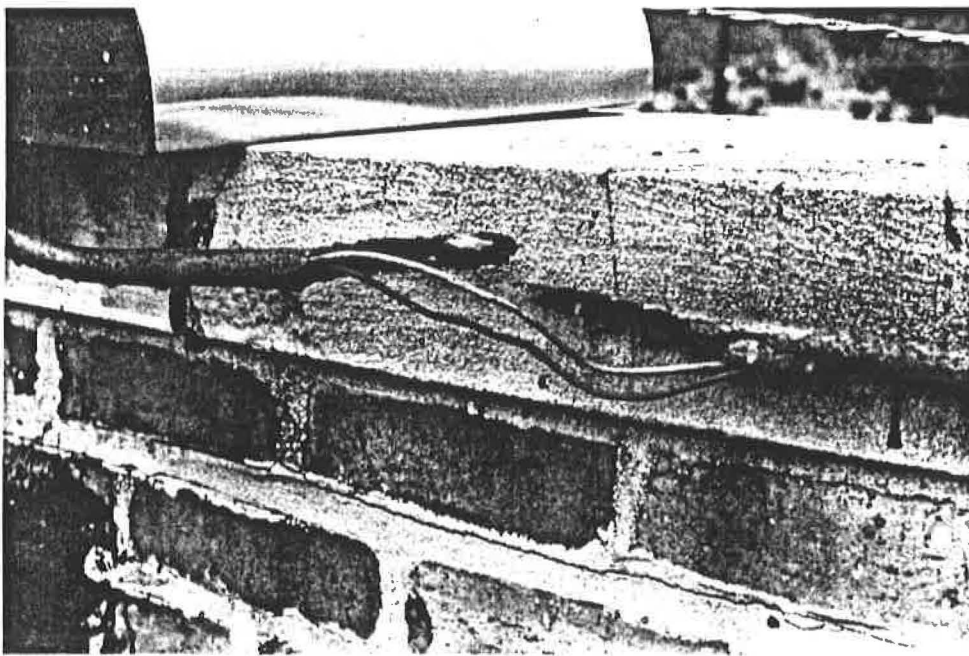
PHOTO E-5  
Eroded conduits  
and exposed wiring  
on roof of west  
building.

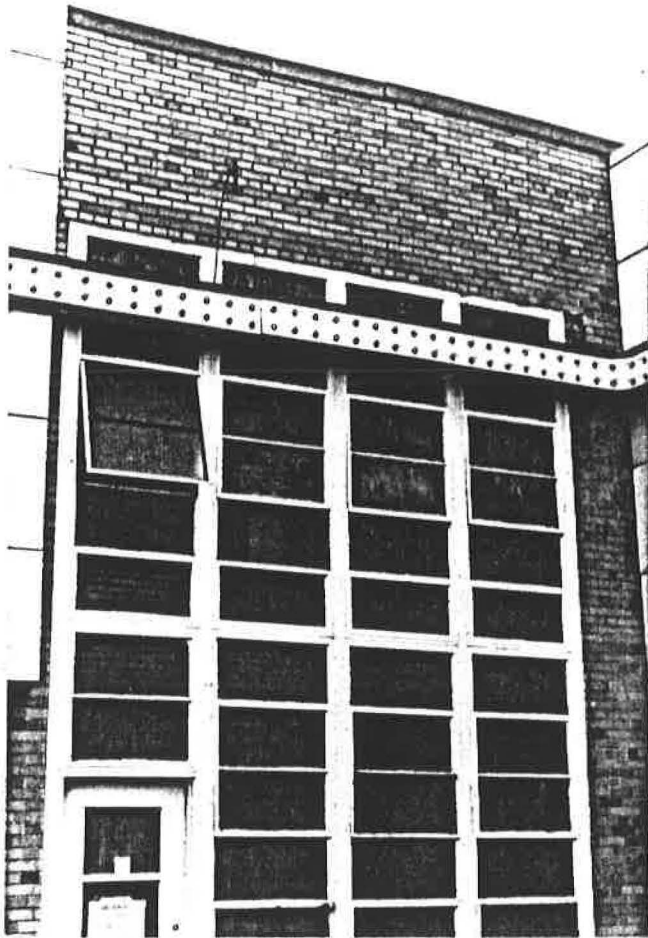
Exposed masonry at parapets, lintels, areas adjacent to foundation, and other areas are deteriorated, as a result of depreciation from inadequate maintenance. Some areas are in early stages of dilapidation. (See Photos S-1, S-2, S-3, S-4, and S-5)

PHOTO S-1  
Diagonal cracking  
in masonry.

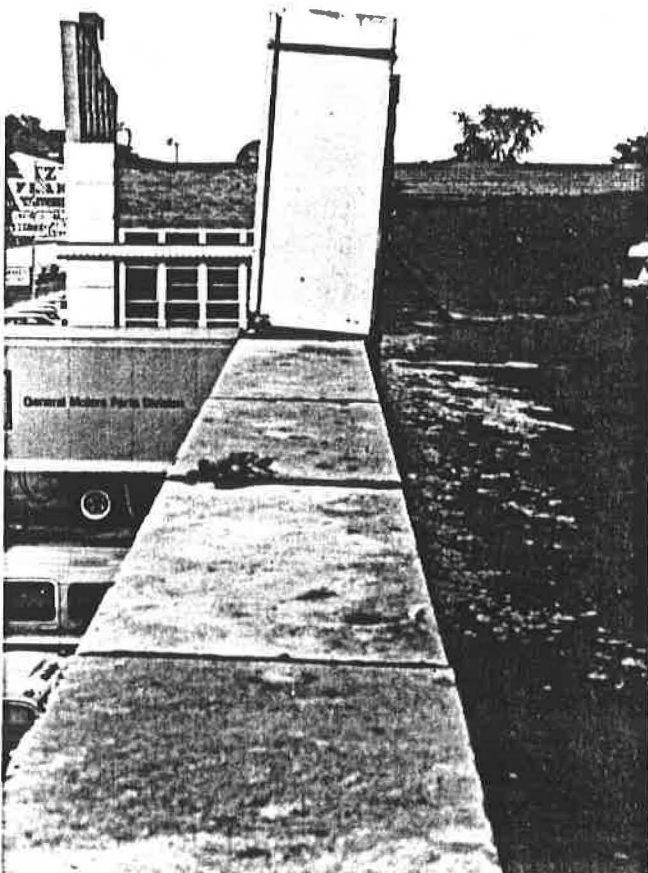
The design of the facility's external appearance,  
its "elevation", is "dated" as evidenced by the fact  
that little remodeling has occurred since  
constructed in 1955. By today's design standards,  
the front of the facility is cluttered with  
excessive signage (See Photo A-3), particularly for  
a facility which essentially contains only two  
functions. Metal panels associated with signage are  
decaying due to water penetration between the  
joints. The top of one of the display walls has  
deteriorated to a point that it is leaning (See  
Photo S-2).

The existing signage and external appearance are  
generally obsolete and showing signs of age and  
deterioration. Partial demolition of some of the  
display wall and dated architectural elements would  
be required to improve the appearance of the  
elevations and avoid failure.

PHOTO S-2  
Parapet leaning  
north.

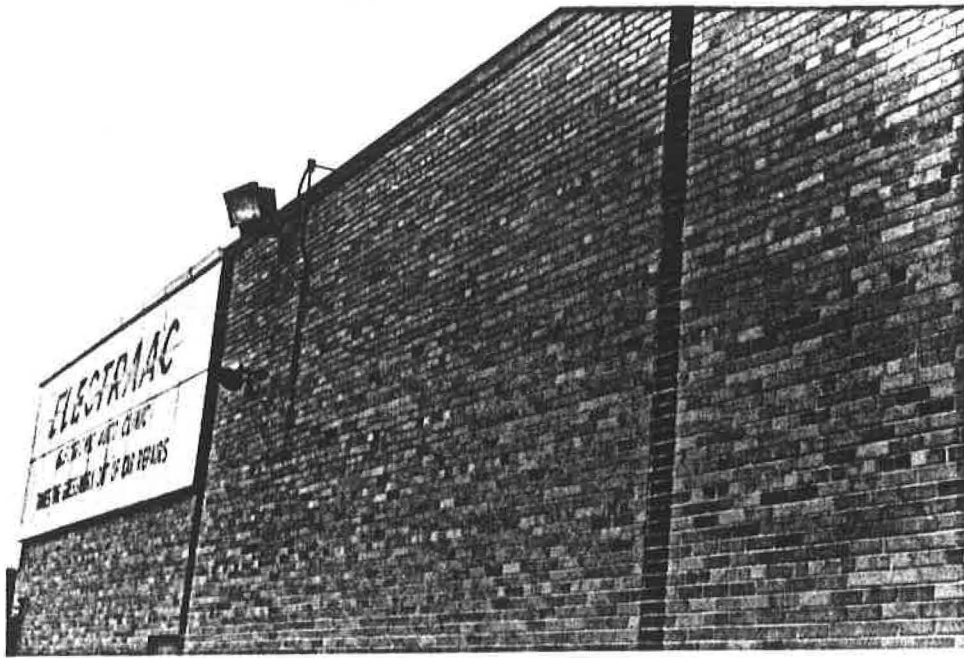
PHOTO S-3  
Exterior masonry  
and joints shown  
deterioration.

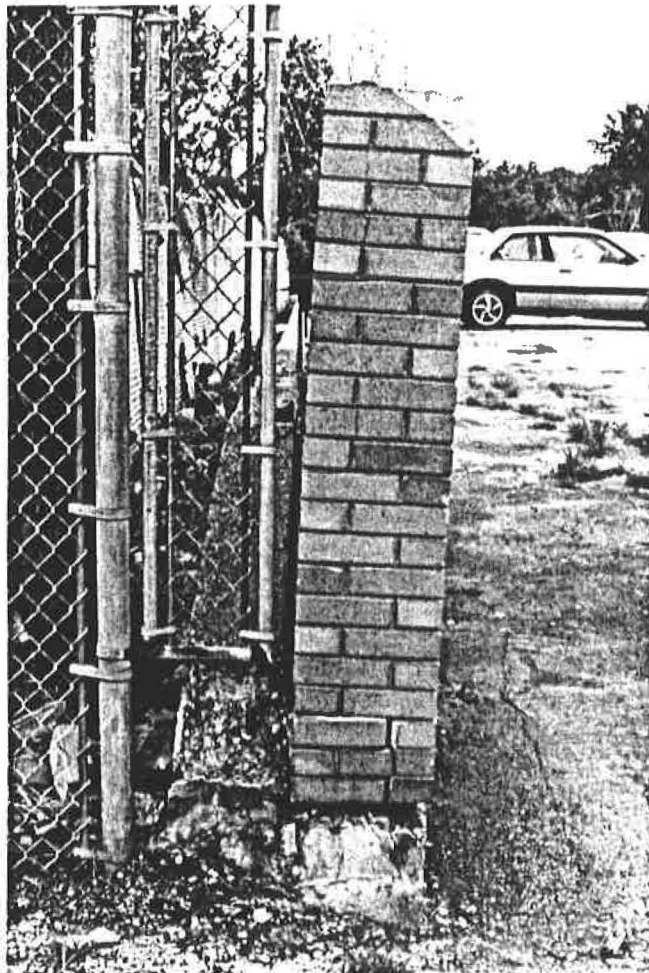
PHOTO S-4  
Deteriorated  
masonry screen  
wall.

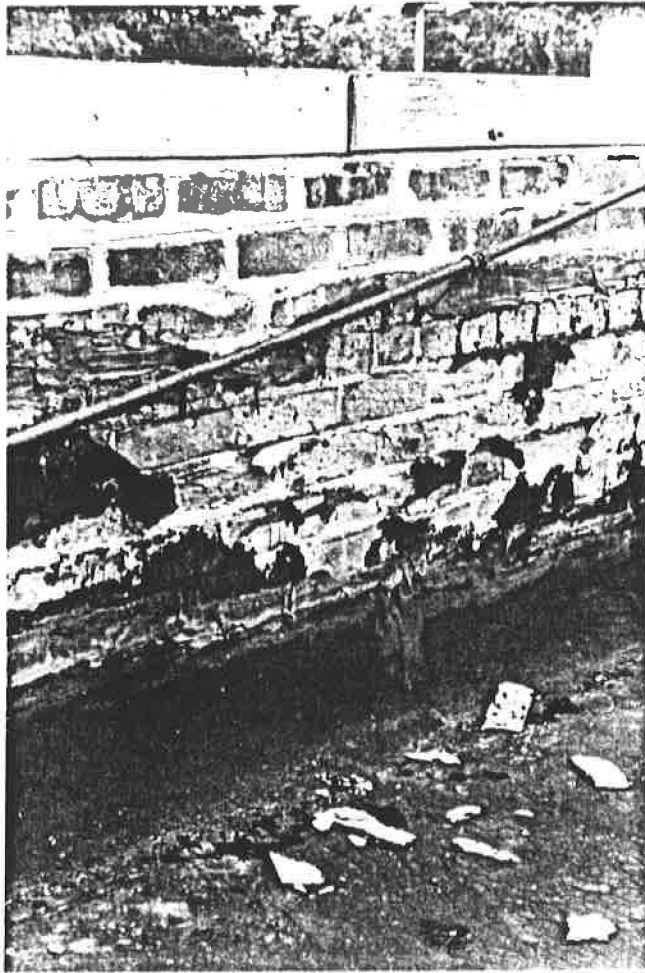
PHOTO S-5  
Spalling,  
deteriorated  
masonry at parapet.

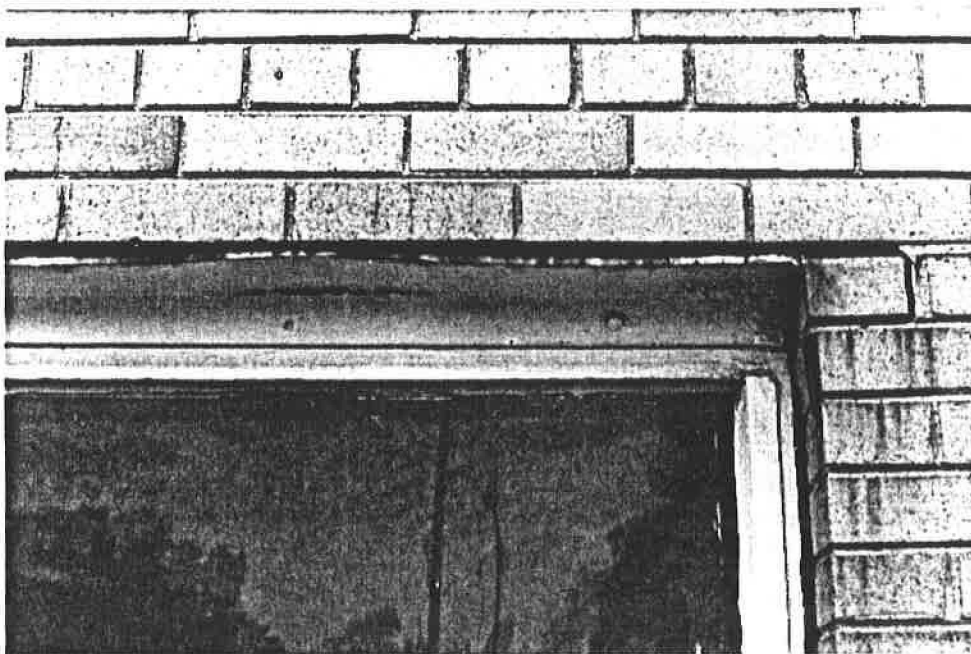
PHOTO S-6  
Buckled lintel  
flanges (close-up).

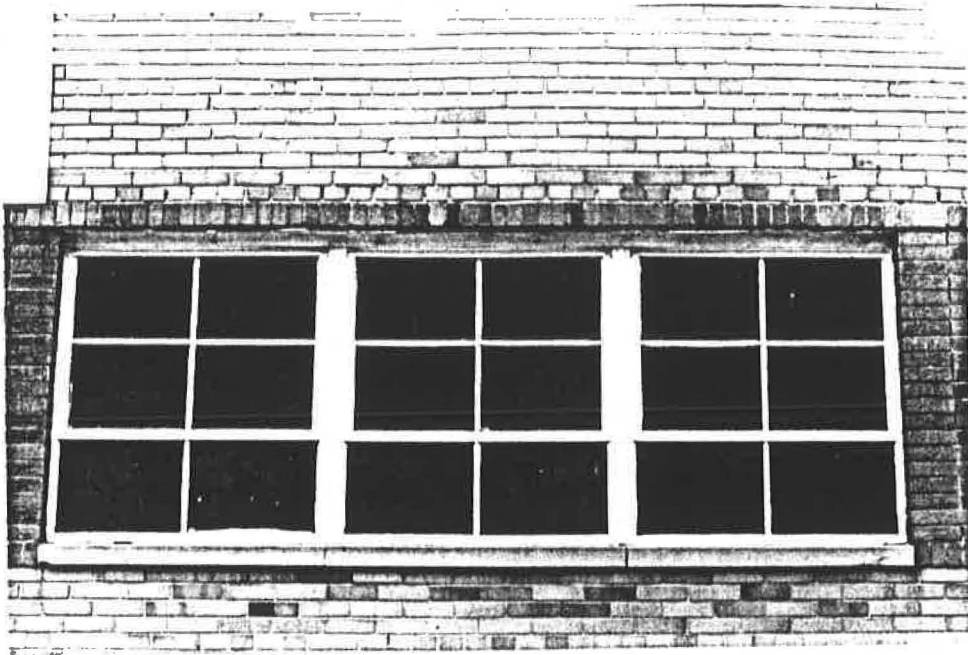
PHOTO S-7  
Buckled lintel.

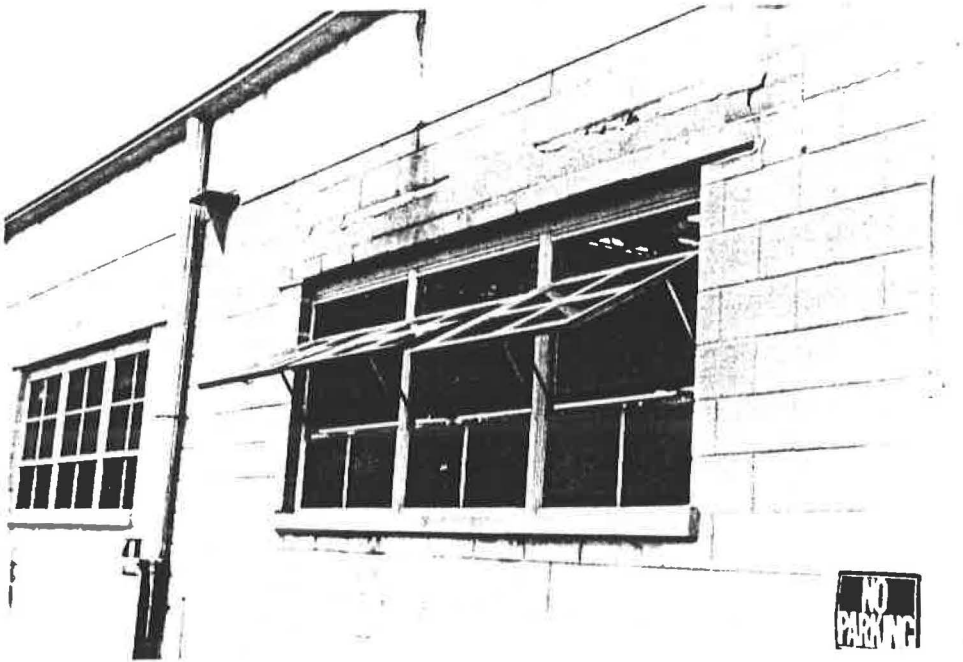
PHOTO S-8  
Buckled block at  
lintel.

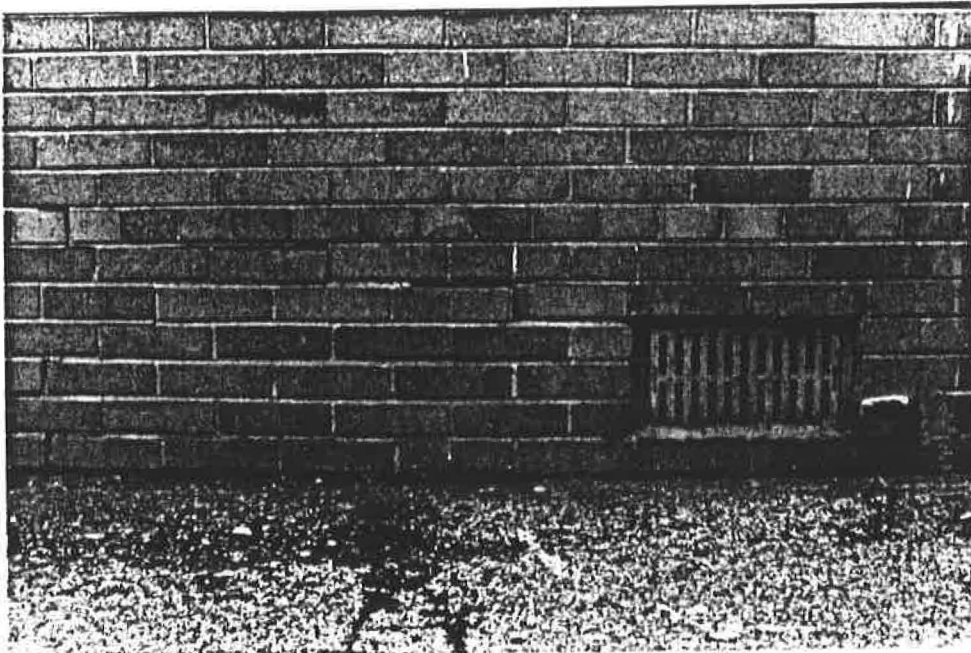
PHOTO S-9  
Diagonal masonry  
cracking at  
settled foundation.

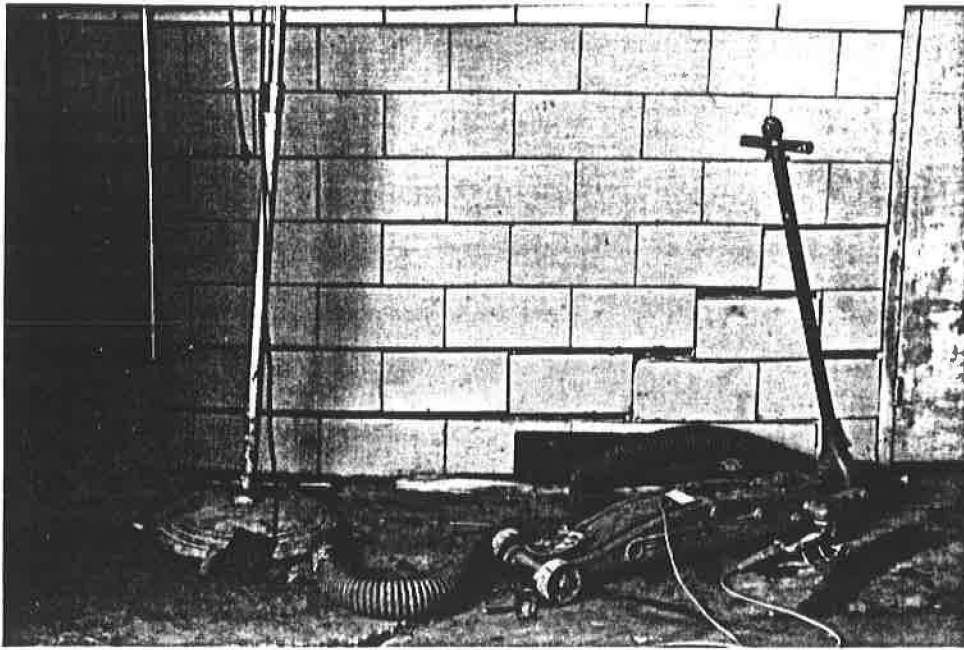
PHOTO S-10  
Diagonal masonry  
cracking at  
settled foundation  
- interior.

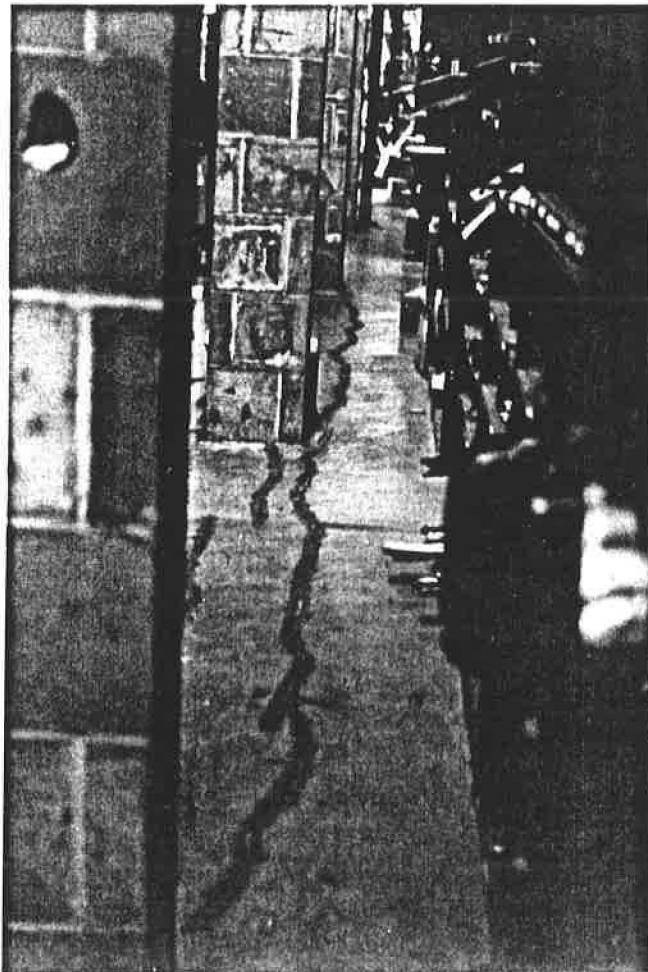
PHOTO S-11  
Shear cracking at  
second floor parts  
storage girder.

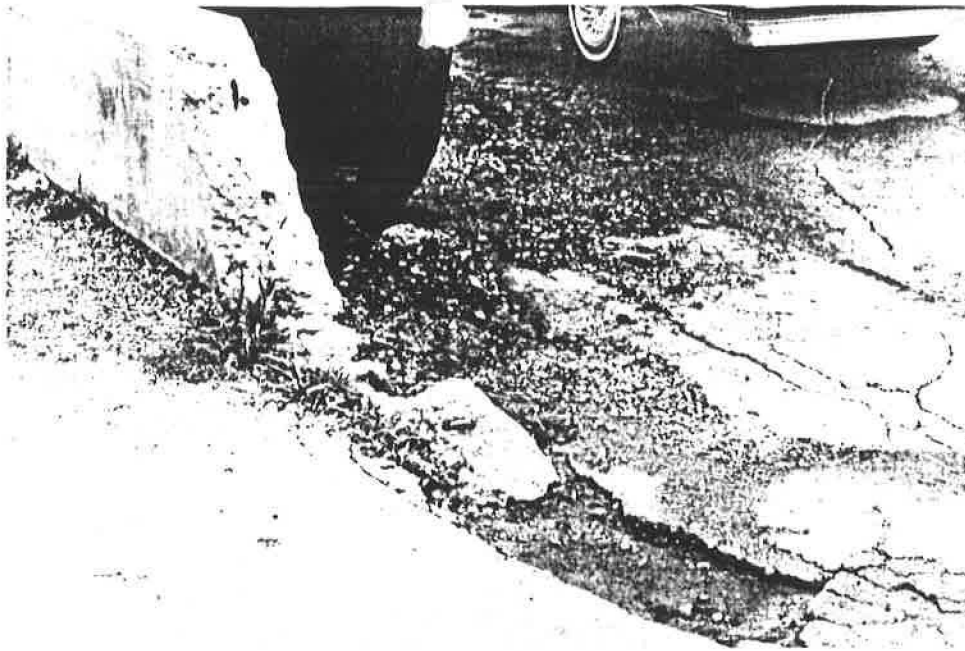
PHOTO S-12  
Deteriorated  
retaining wall  
near service  
addition.

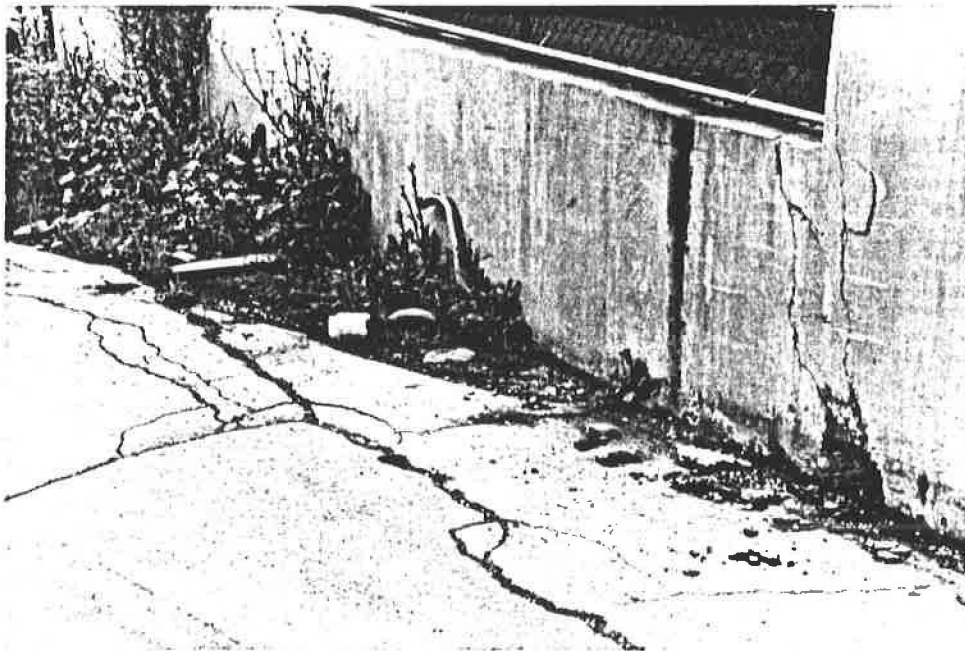
PHOTO S-13  
Exterior of  
retaining wall.
