WEST RIDGE--PETERSON AVENUE  
REDEVELOPMENT PLAN AND PROJECT

Finally, this Report summarizes the existing conditions according to the applicable criteria referred to in the Act and outlined above as Items 1 through 14. Photographs are used where appropriate to illustrate existing blighted conditions. Photographs appear as Exhibit D and are referenced throughout the text.

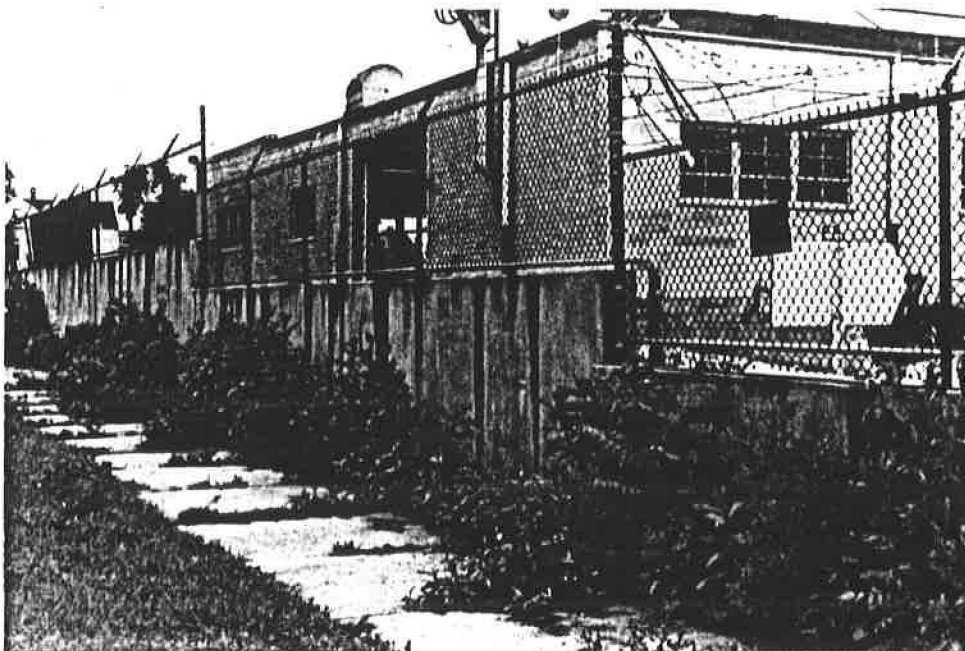
PHOTO S-14  
Exterior retaining  
wall.
