NARRATIVE EVALUATION

SITE NAME: Crawford Smoke Stack Demo

SITE ADDRESS: 3501 S PULASKI RD, CHICAGO, IL 60623

INSPECTION #: 1530373

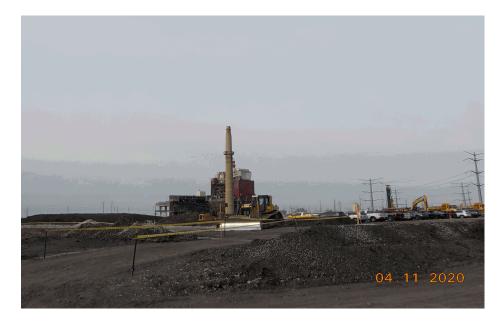
COMMENTS: Photo A- 3501 S. Pulaski Rd., Photo of smokestack before implosion.

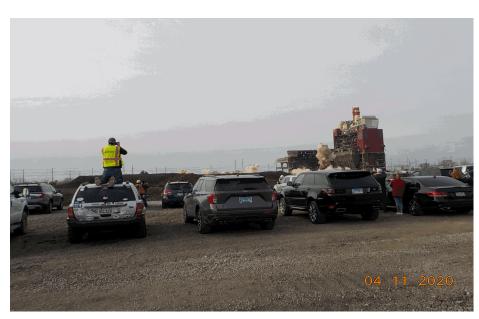
COMMENTS: Photo B- 3501 S. Pulaski Rd., Photo of initial impact of smokestack after implosion detonation.

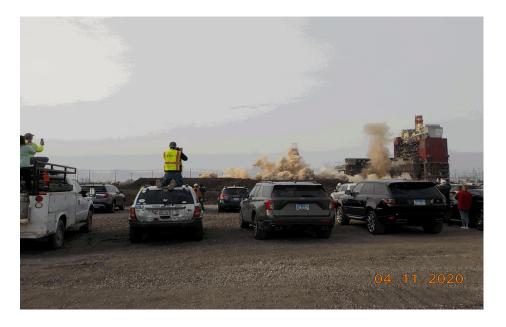
Weather conditions were slightly overcast at 7:38 A.M. The temperature was 45 degrees Fahrenheit. At approximately 7:58 a two-minute-long siren was sounded followed by the explosive detonation at approximately 8:00 A.M. The structure toppled east as planned and generated a plume of dust upon impact with the ground.

COMMENTS: Photo C- 3501 S. Pulaski Rd., Photo of dust cloud generated by smokestack upon impact with ground.

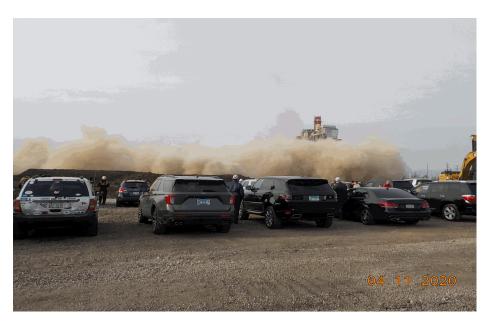
A wind current from the south to north carried the plume of dust through the site due north. The cloud of dust was thick as it traveled through the site. Visibility was limited due to the dust. Two rented water trucks stationed at the northern perimeter of the site were hosing the area to prevent the dust cloud from exiting the site. The reporting inspector's line of sight was positioned westward as the dust cloud traveled northbound. The reporting inspector did not observe what CFD was doing at the time due to the inspector's line of sight. The dust was not suppressed adequately and continued to travel off-site towards the residential area north of the site.

COMMENTS: Photo D- 3501 S. Pulaski Rd., Photo of dust cloud moving north from impact drop area.

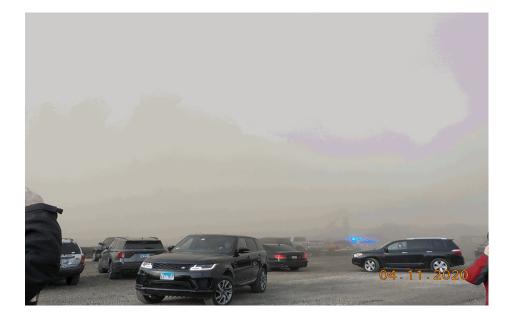
COMMENTS: Photo E- 3501 S. Pulaski Rd., Photo of dust cloud continuing to move north from impact drop area. Thick

cloud of particulates can be seen.

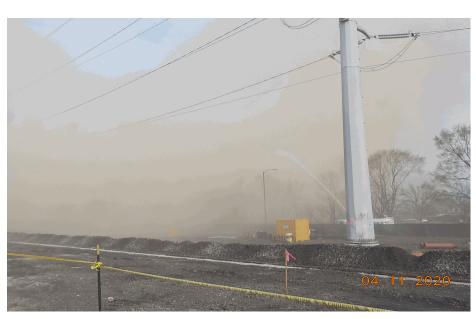
MCM Industrial Services LLC/MCM Management Corp. failed to take reasonable precautions to minimize wind borne particulates from the demolition of the smoke stack. MCM Industrial Services LLC/MCM Management Corp. failed to adequately wet the smoke stack demolition area to prevent the emission or dispersion of dust. MCM Industrial Services LLC/MCM Management Corp. failed to adequately wet the site in order to prevent the off site dispersion of the dust and therefore also caused a nuisance. MCM Industrial Services LLC/MCM Management Corp. did not have adequate dust control measures in place which allowed the demolition of the smoke stack to generate and disperse dust to the adjacent residential area. By allowing the dust to migrate off site, MCM Industrial Services LLC/MCM Management Corp. generated conditions detrimental to the health of the nearby residents, and therefore also created a nuisance.

COMMENTS: Photo F- 3501 S. Pulaski Rd., Photo of dust cloud can be seen moving north onto residential area. Water

truck can be seen hosing water.

Based on this information the reporting inspector will issue citations to MCM Industrial Services LLC/MCM Management Corp. based off the City of Chicago Ordinance: 11-4-2170(b)(1) Demolitions and renovations: control and disposal of dust and debris, 11-4-760(a) Handling and storage of material susceptible to becoming windborne, 13-32-125(2)(a) Construction site cleanliness, and 7-28-080 Nuisance in connection with business. The Citation numbers are E000035810 10 and E000035811 11. The hearing date is August 6, 2020.

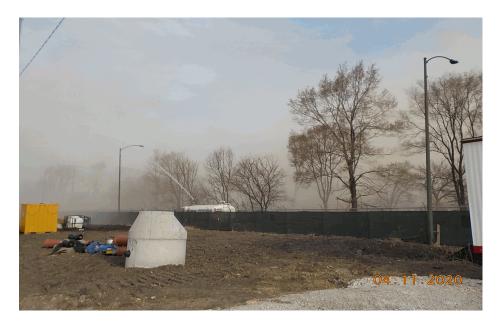
COMMENTS: Photo G- 3501 S. Pulaski Rd., Photo of dust cloud continuing to migrate north.

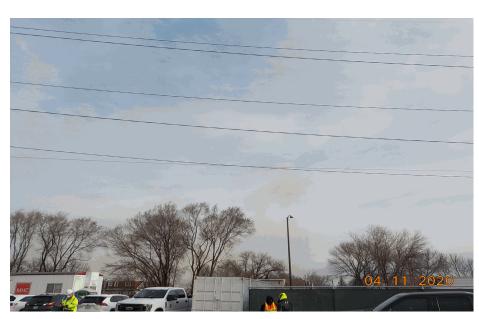
COMMENTS: Photo H- 3501 S. Pulaski Rd., Photo of dust cloud continuing to move north.

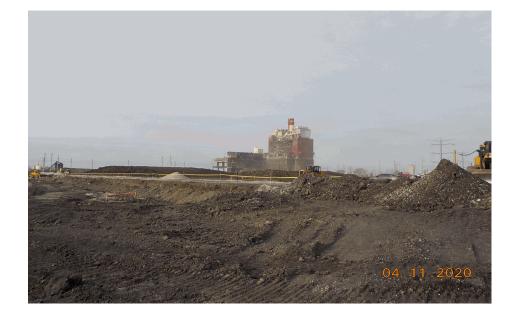
COMMENTS: Photo I- 3501 S. Pulaski Rd., Photo of area where smokestack was dropped. Dust can still be seen.

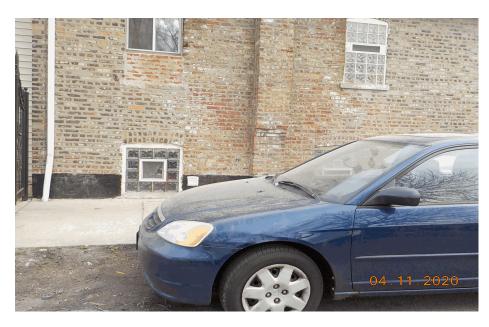
The cloud of dust slowly dispersed and became less thick as it continued to travel northbound. The reporting inspector then drove around the residential area directly north of the site to view if any residual dust from the cloud had settled. The reporting inspector observed dust on multiple cars and on trees.

COMMENTS: Photo J- 3501 S. Pulaski Rd., Photo of car located in residential area north of site. Dust can be seen on

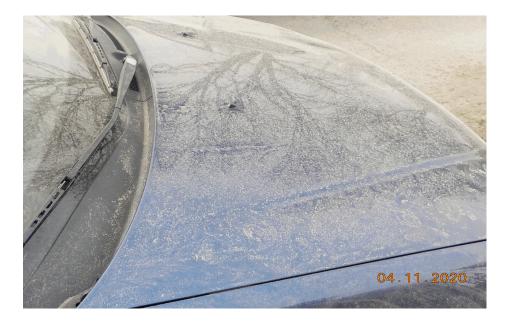
COMMENTS: Photo K-3501 S. Pulaski Rd., Photo of car located in residential area north of site. Settled dust can be

seen on car.

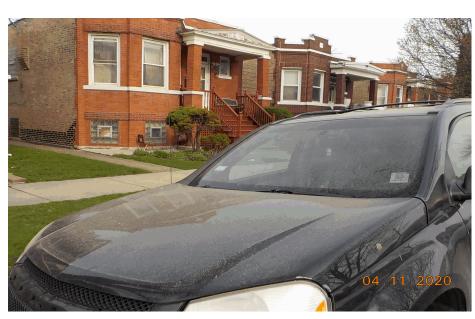
COMMENTS: Photo L-3501 S. Pulaski Rd., Photo of car located in residential area north of site. Settled dust can be

seen on car.

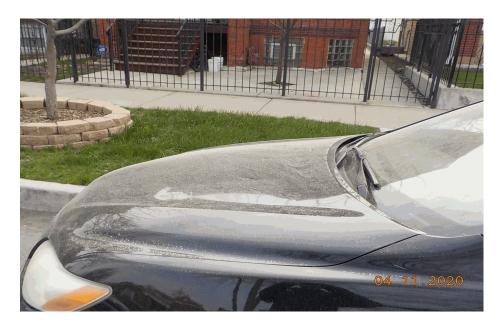
COMMENTS: Photo M-3501 S. Pulaski Rd. Photo of settled dust on car located in residential area north of site.

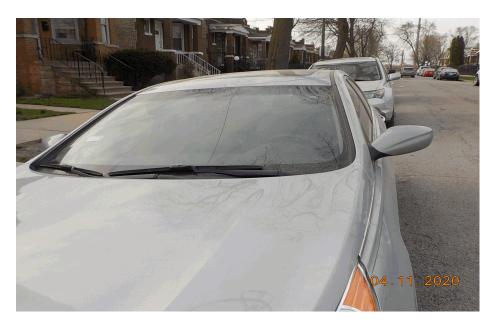
COMMENTS: Photo N-3501 S. Pulaski Rd. Photo of car with settled dust located in residential area north of site. Car is facing north. Site where implosion took place can be seen in the rear.

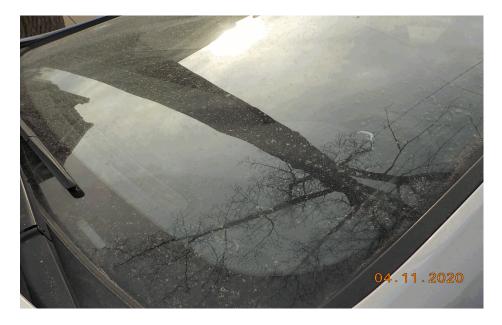
COMMENTS: Photo O-3501 S. Pulaski Rd. Closer view of car facing north. Settled dust can be seen.

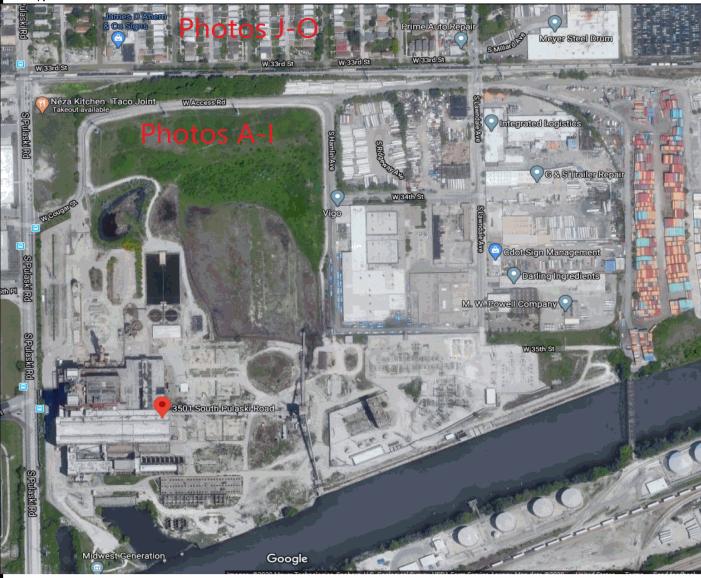
SITE SKETCH

***Not drawn to scale. Aerial imagery may not be representative of actual site conditions at the time of inspection.
