## Appendix A: Chicago Arrow Terminal – Incremental Dust Control Procedures and Decision

NARRATIVE EVALUATION

INSPECTION DATE: 12/01/2016
SITE NAME: KINDER MORGAN
SITE ADDRESS: 2926 E 126TH ST, CHICAGO, IL 60633
SITE CODE: KINDER MORGAN
PERMIT #: ENVAIR113986

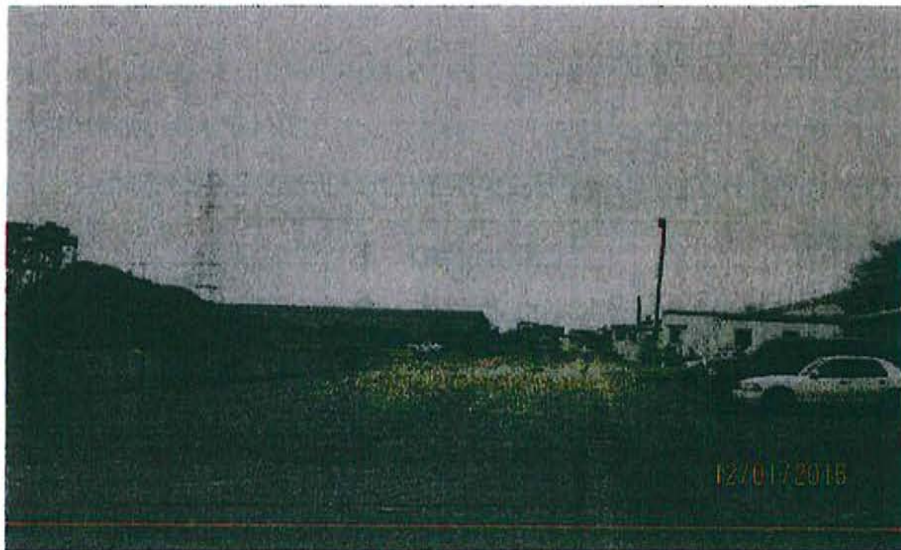
COMMENTS: Photo #1 Direction: NW Comments: No pole mark for 30 feet material height limit, anywhere in the facility.

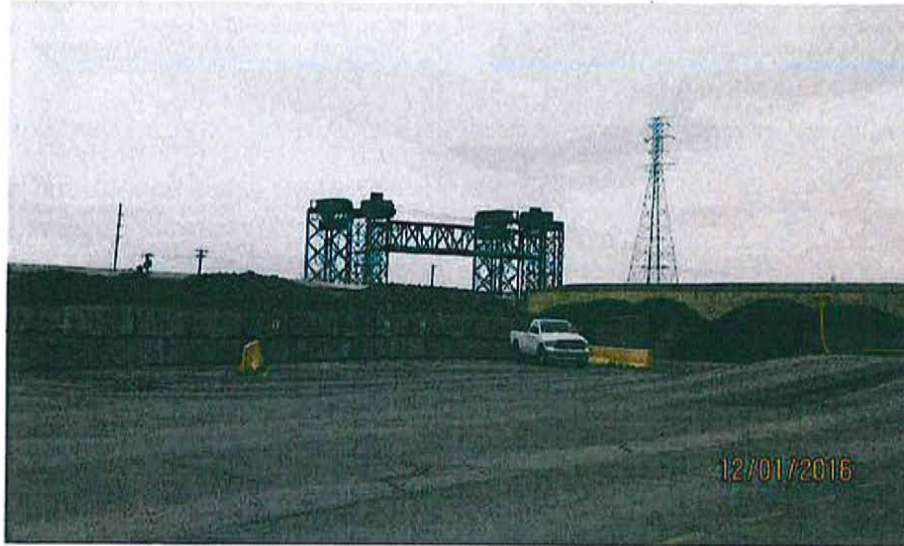
COMMENTS: Photo #2 Direction: NW Comments: This photo shows dry and dusty road.

Today's inspection revealed the following: The access roads were very dry and dusty. I did not observe any sweeper nor water truck in operation as at the time of this inspection (see photo #s 2, 3, 4 & 5). According to the daily street sweeper/water truck log obtained from the facility; between January 2016 to August 2016, there was no indication or record that water was applied on the roads (the log only indicated sweeping). I observed track-out on 126th Street (see photo #4). Material pile height appeared to be approximately just below 30ft. No post mark for 30 feet bulk material height was visible anywhere on the facility ( see photo #1). I observed truck wheels driving through, picking up and dispersing dust. There is no berm at the river edge to protect material from falling into the river, during loading and unloading operations (see photo #5). See the attachments.

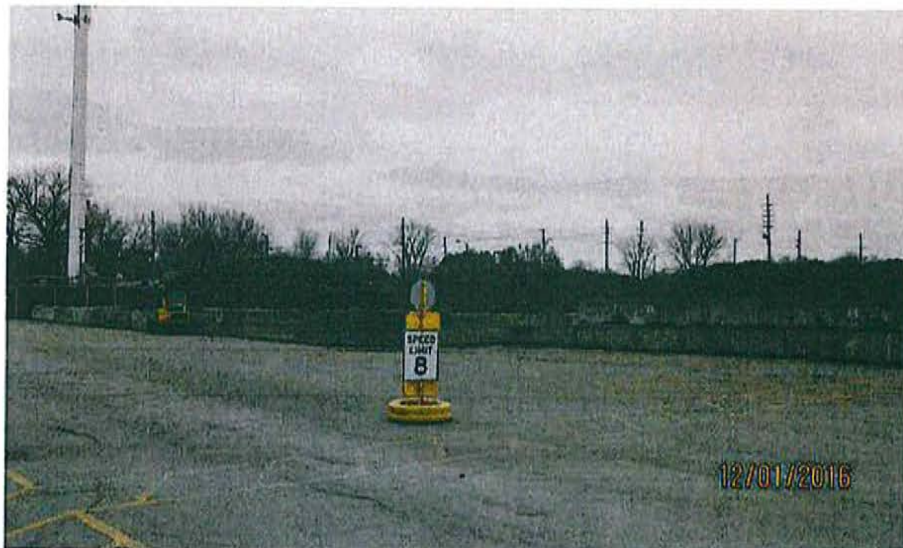
COMMENTS: Photo #3 Direction: SW Comments: This photo shows dry and dusty road.

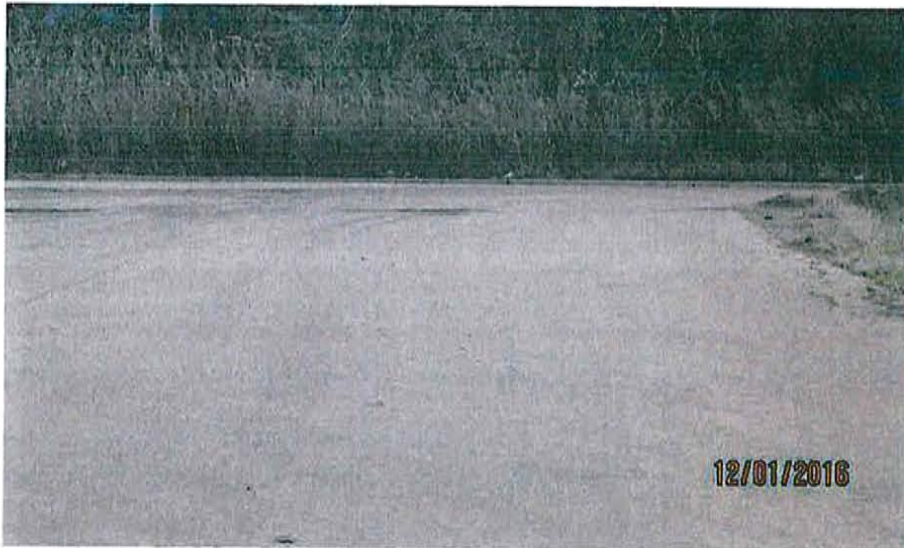
COMMENTS: Photo #4 Direction: SW Comments: This photo shows dry and dusty road and track-out on 126th Street.

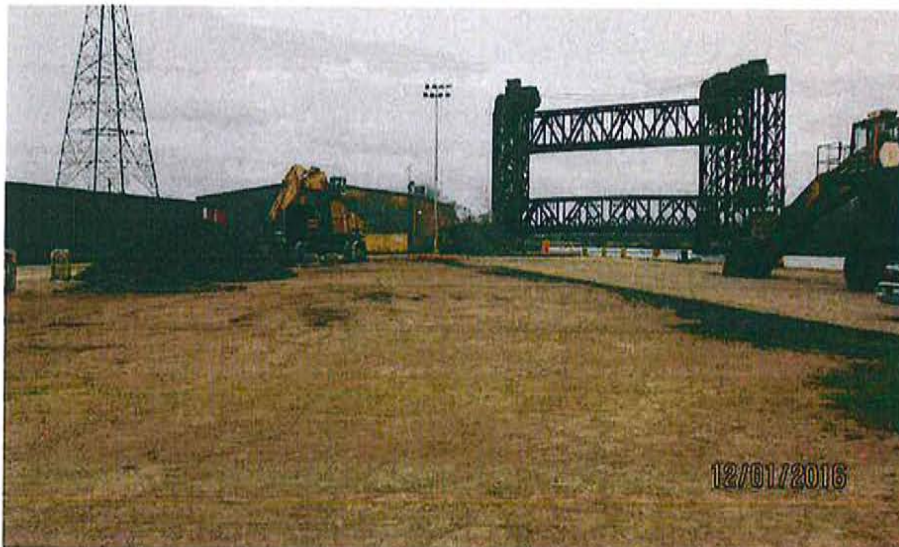
COMMENTS: Photo #5 Direction: NW Comments: This photo shows dry and dusty road. The edge of Calumet River was without berm to protect material from falling into the river.

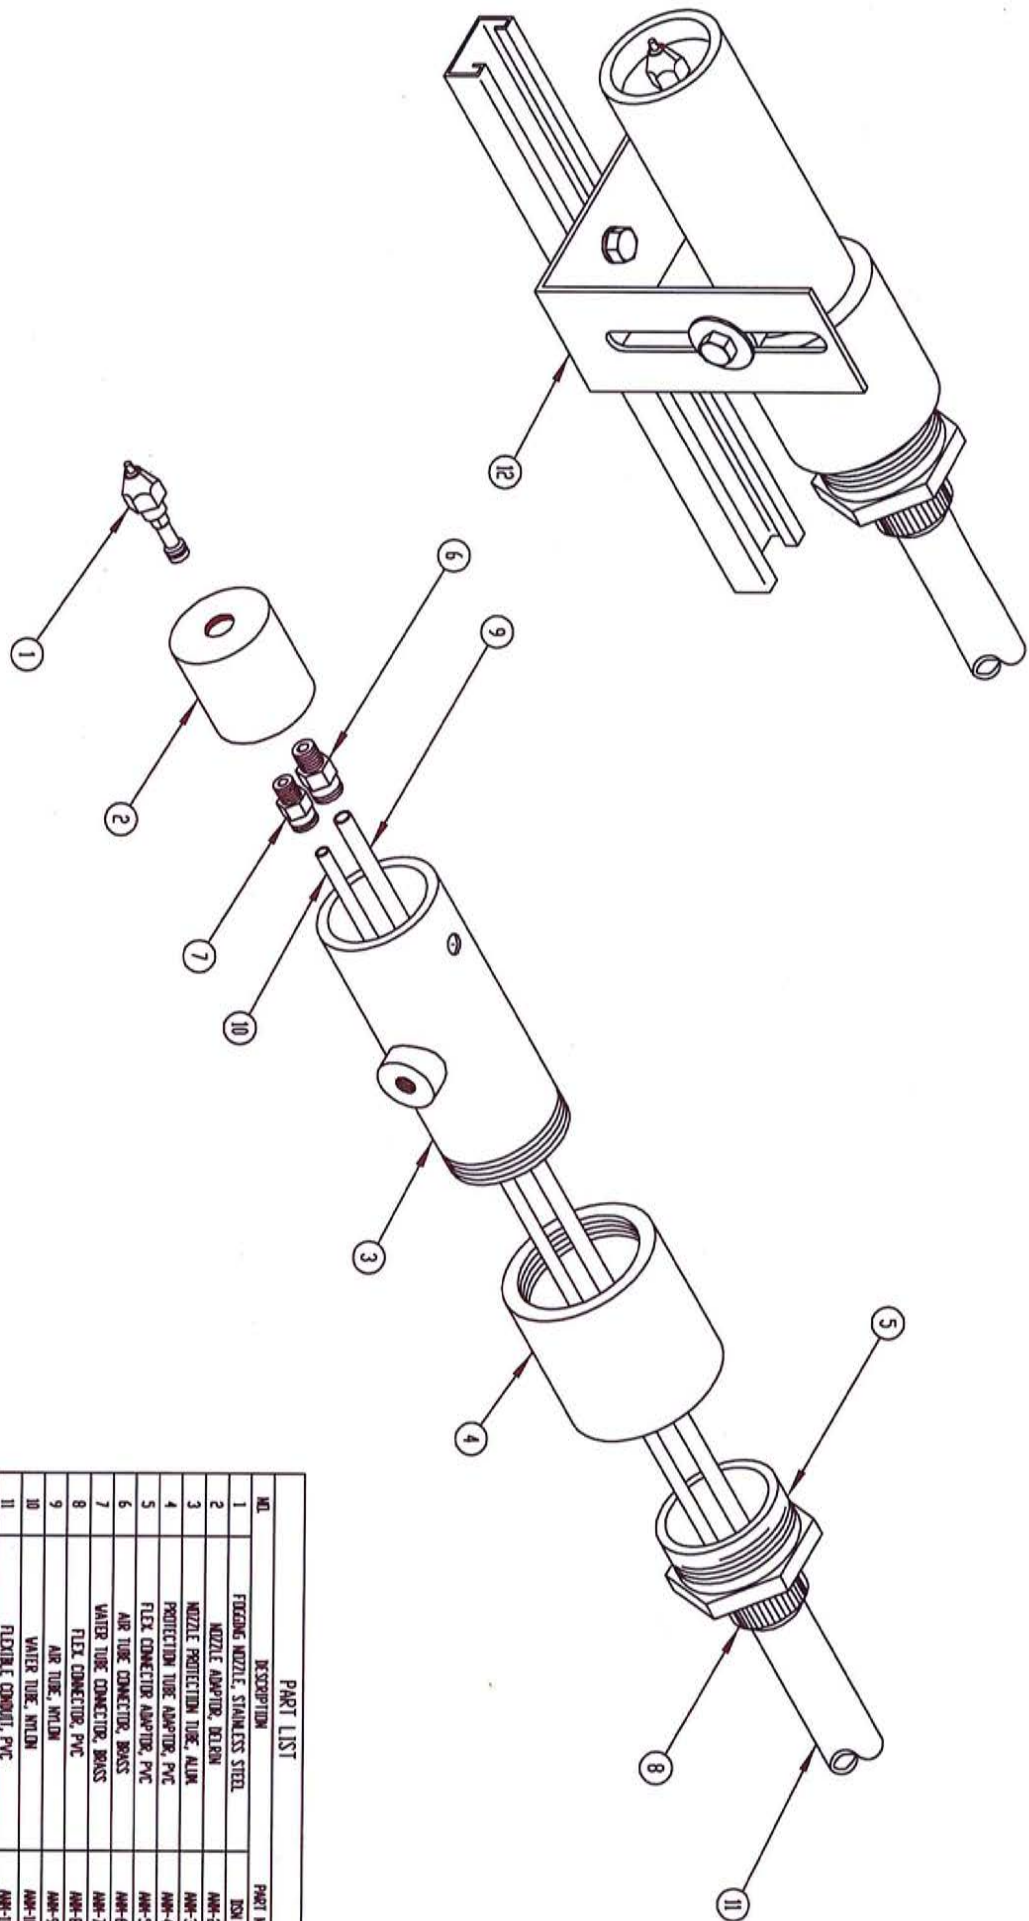
FOGGER NOZZLE MOUNT ASSEMBLY

NO	DESCRIPTION	PART NO.
1	FIRING NOZZLE, STAINLESS STEEL	NSN
2	NOZZLE ADAPTER, BERYL	AM-2
3	NOZZLE PROTECTION TUBE, ALUM	AM-3
4	PROTECTION TUBE ADAPTER, PVC	AM-4
5	FLEX CONNECTOR ADAPTER, PVC	AM-5
6	AIR TUBE CONNECTOR, BRASS	AM-6
7	WATER TUBE CONNECTOR, BRASS	AM-7
8	FLEX CONNECTOR, PVC	AM-8
9	AIR TUBE, NYLON	AM-9
10	WATER TUBE, NYLON	AM-10
11	FLEXIBLE CONDUIT, PVC	AM-11
12	ANGLE BRACKET, ALUM.	AM-12
13	HEAT TRACE CABLE OVERT SPRING	AM-13

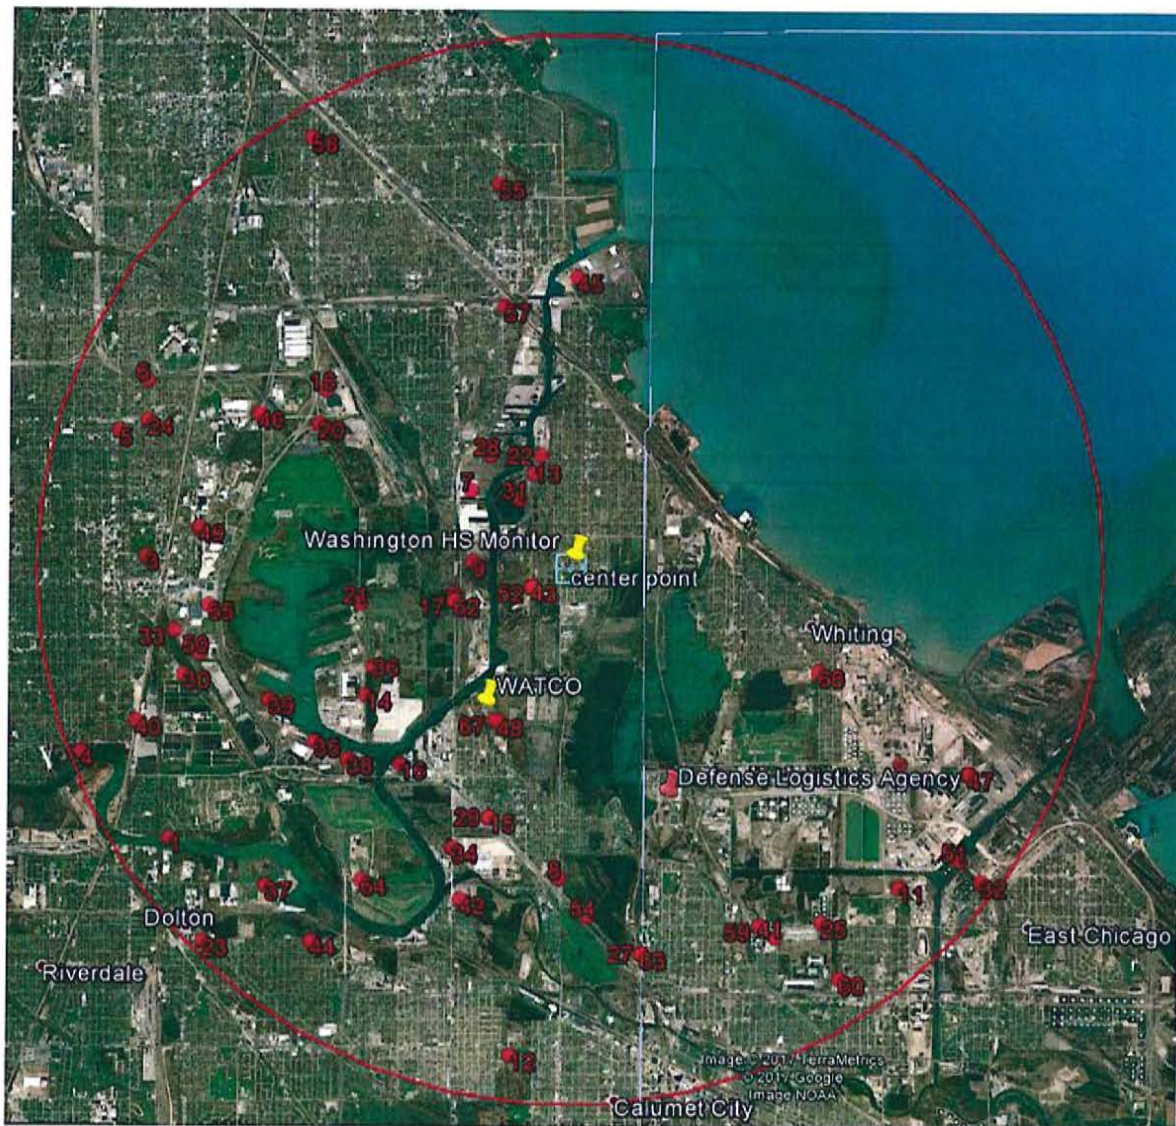
Figure 3. Location of Other Sources (Not Reported to be Emitting PM<sub>10</sub>)

Source: EPA ECHO Database (sites were included in ECHO database but not reported to emit PM<sub>10</sub>)
